KEYSTONE
ENGINEERING &
CONSULTING, INC.

Progress Inspection Report #60
Permit # 18BC03039

Project Name: East Horizon
Project Address: 401 Highway A1A, Satellite

Progress Report thru 5-10-19
Inspection Visits: 5-6 thru 5-9

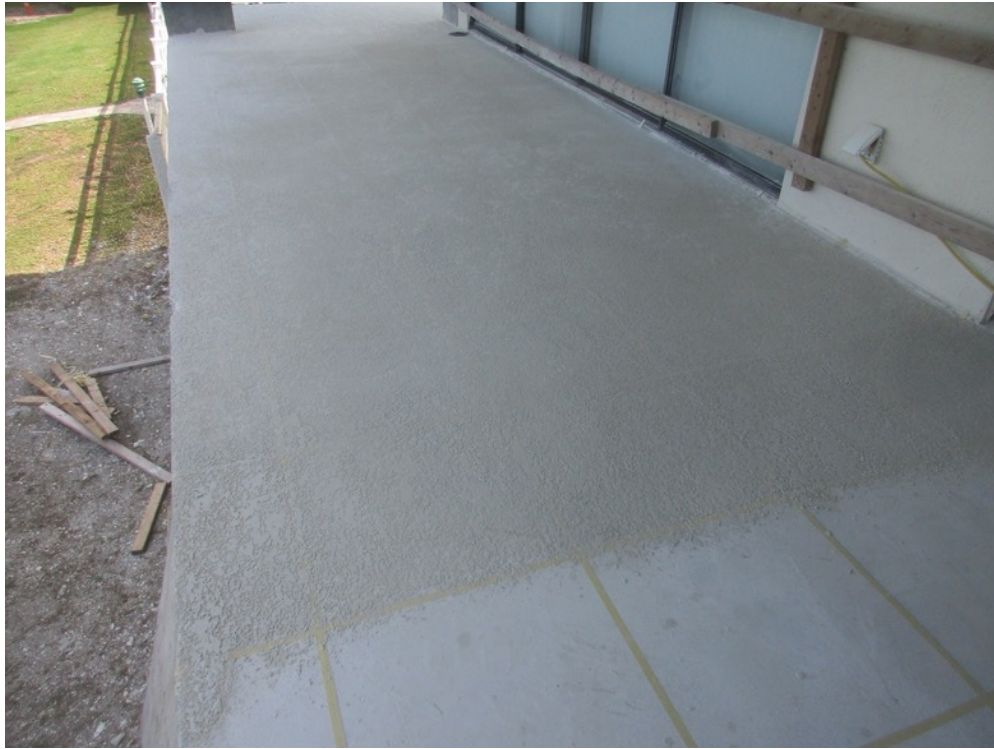
On the building 3 balconies, plywood protection has been constructed on the 01 stack northeast corner over the pool pump area. Tile pattern knockdown texture application has been applied on the Unit 214 southeast corner balcony deck and final surface preparation sanding is now wrapping up on the 04 stack southeast corner balconies in order to begin applying waterproofer deck coats.

View of knockdown texture application in-progress on the Unit 214 balcony deck

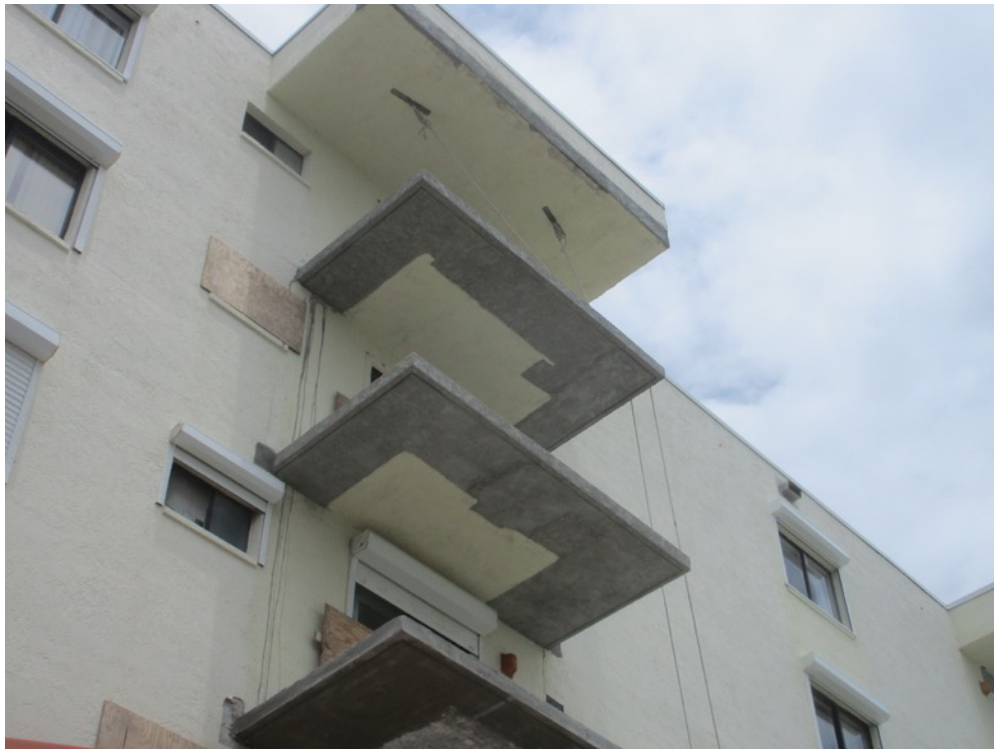
Stucco finish is now being applied to repaired areas on the 04 southwest kitchen stack balconies, completed on the 4th and 5th floors and scheduled to continue on remaining Units next week. Sliding glass door reinstallations on the Unit 211 balcony are scheduled to begin next week.

View of stucco finish applied to repaired areas on the Unit 244 and 254 SW kitchen balconies

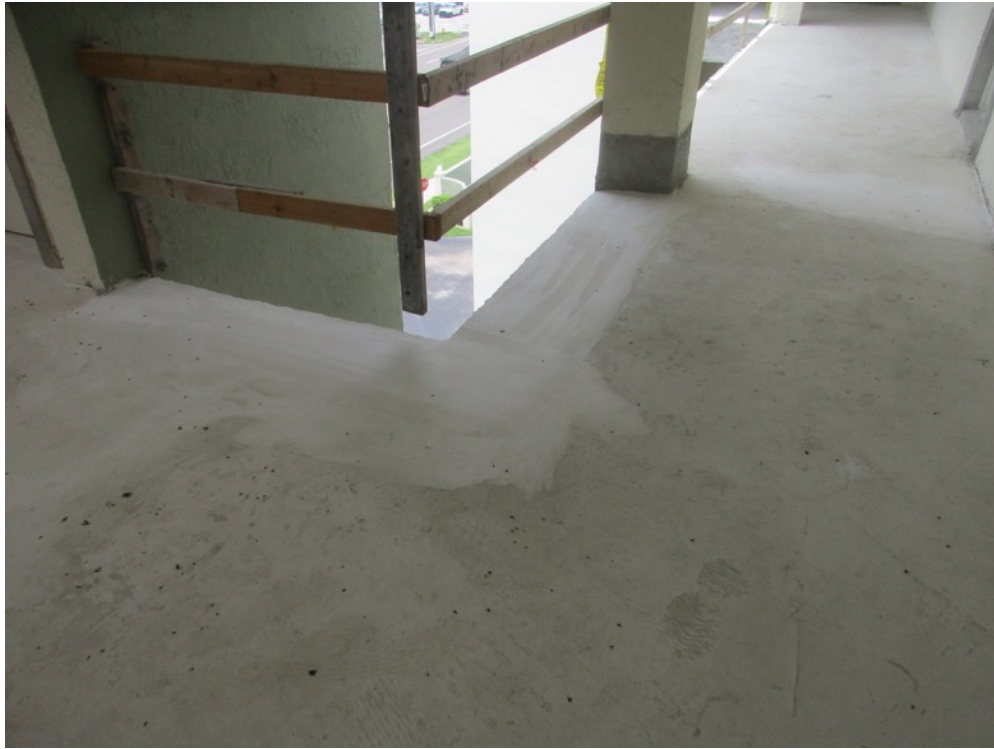
View of final surface profiling completed on the 5th floor walkway elevator area

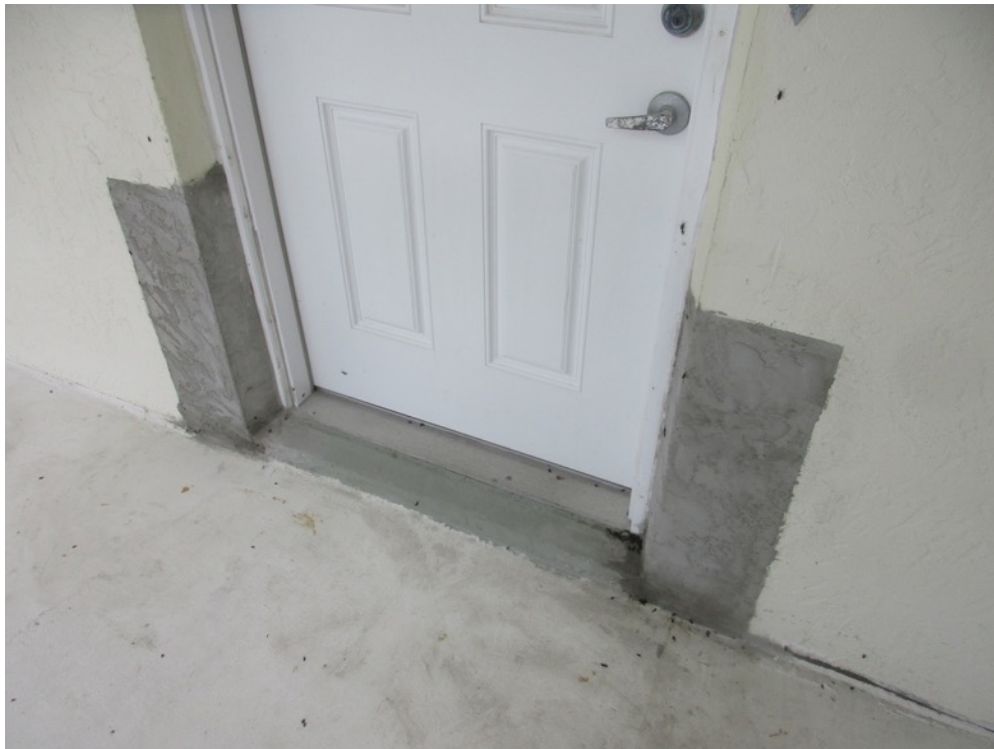
View of stucco finish applied to column repairs at the Unit 252 walkway entry door

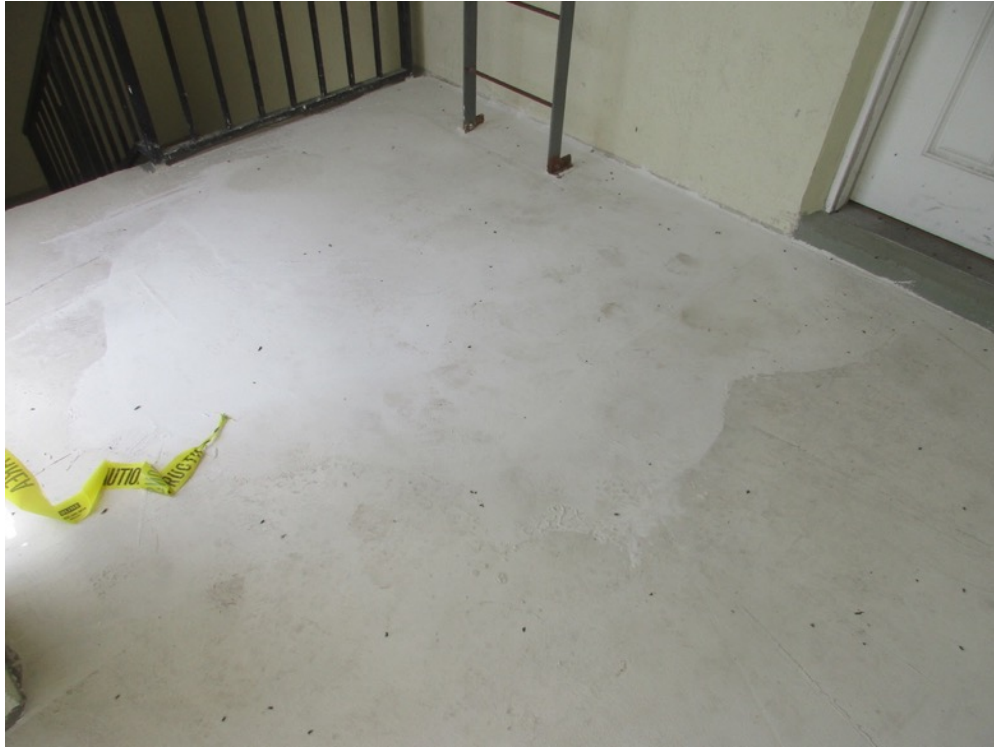
View of final surface profiling completed outside Unit 251 on the walkway

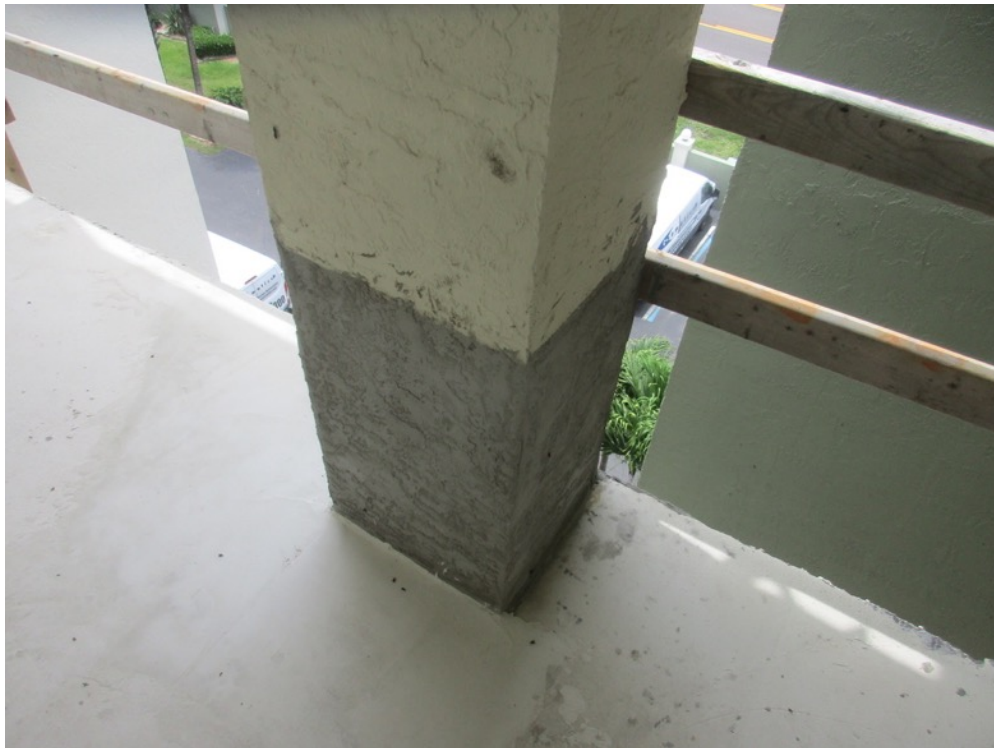
View of stucco finish applied to column repair outside Unit 243 on the walkway

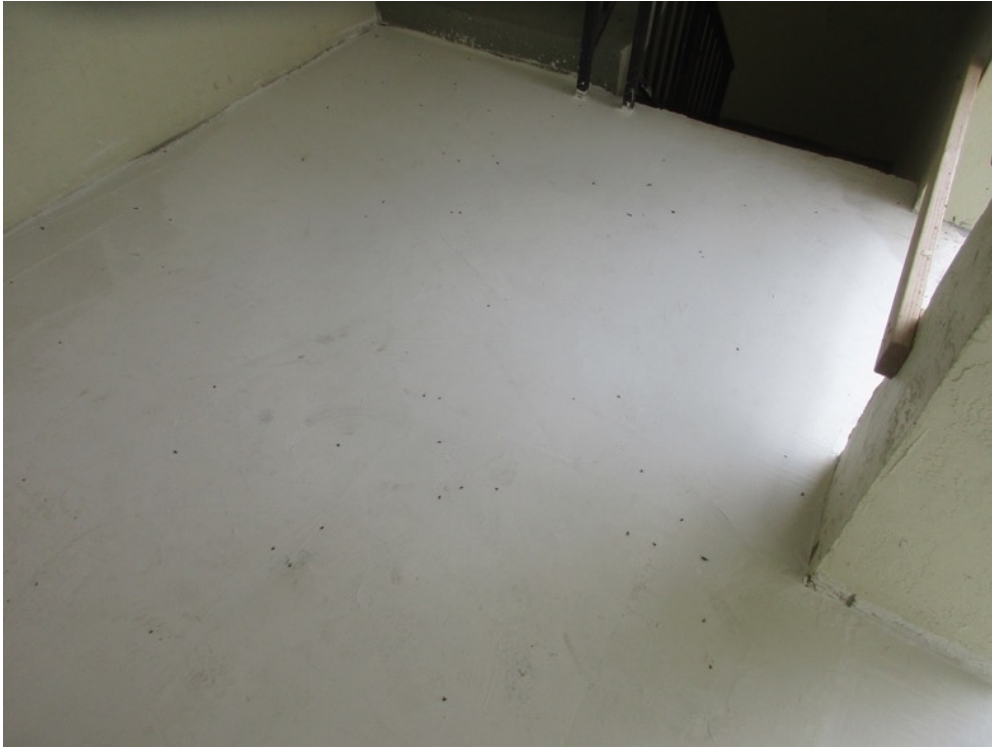
View of final surface profiling completed outside Unit 244 on the walkway

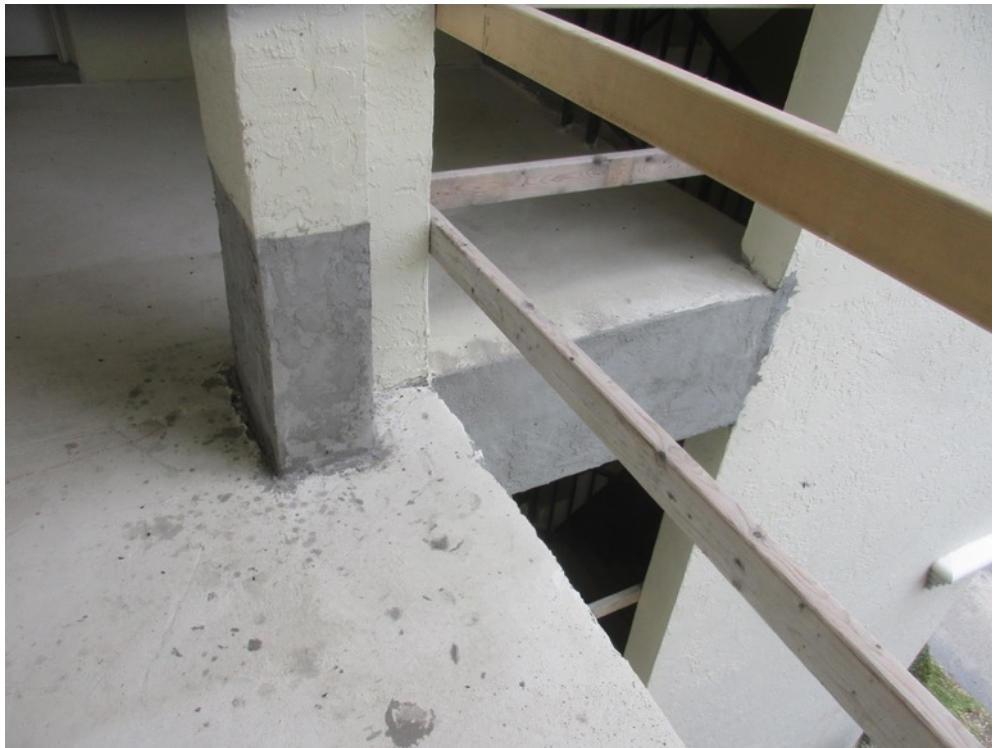
View of stucco finish applied to column and slab edge repair outside Unit 234 on the walkway

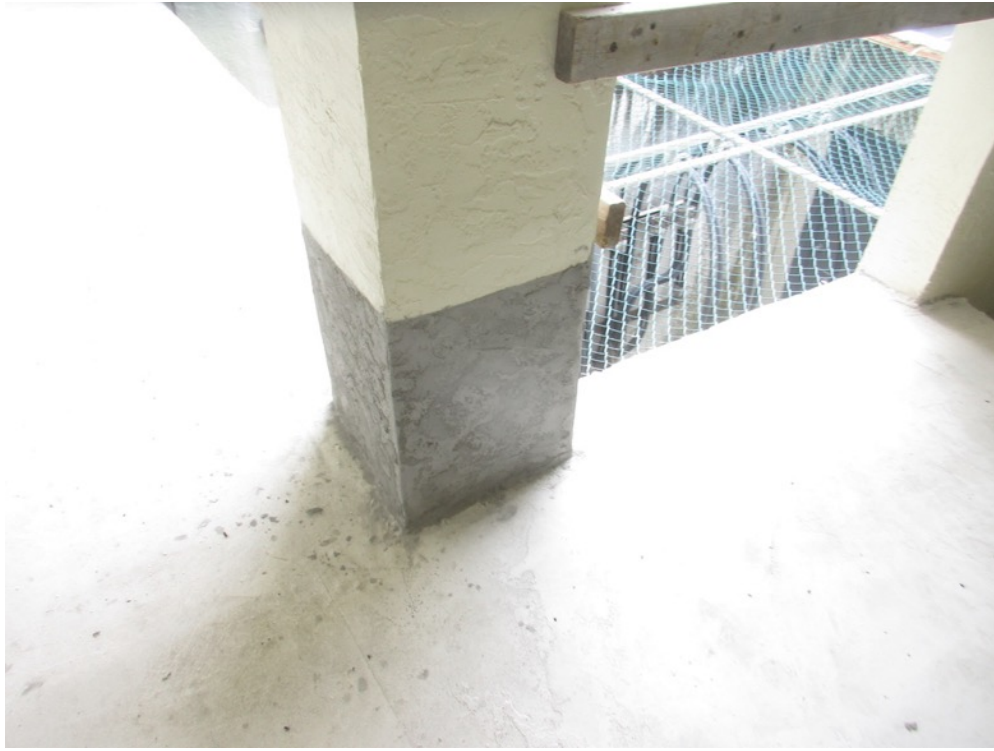
View of stucco finish applied to column repair outside Unit 211 on the walkway

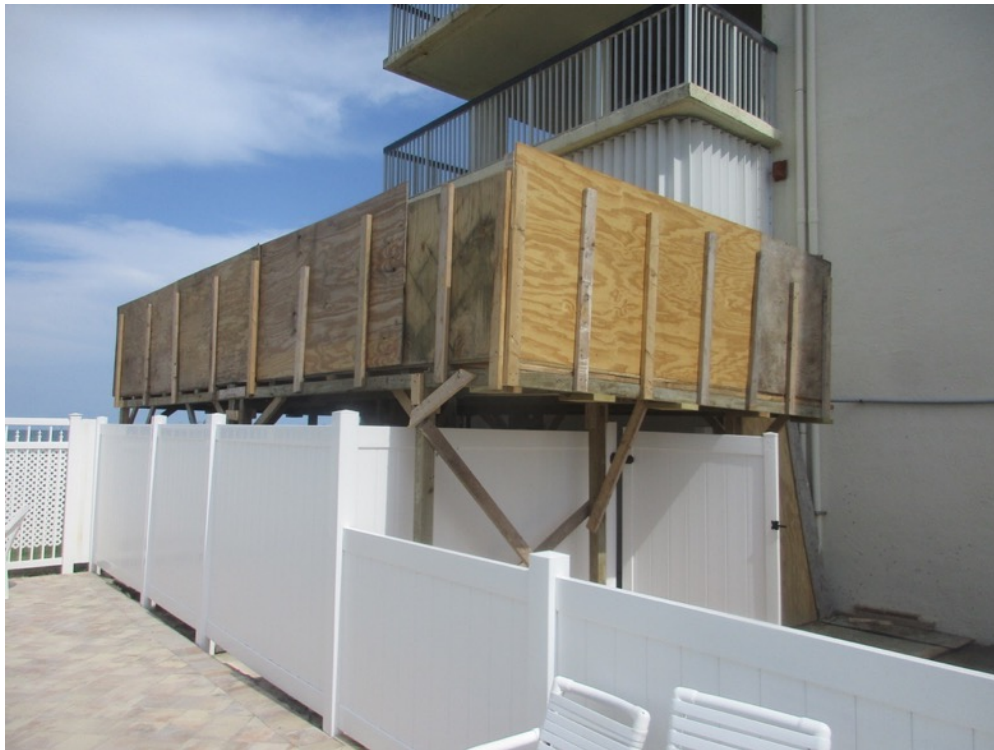
View of pool pump protection constructed on the building 3 northeast corner
