## **Progress Inspection Report #40** **Permit # 18BC03039**

Project Name: East Horizon  
Project Address: 401 Highway A1A, Satellite

Progress Report thru 12-21-18  
Inspection Visits:

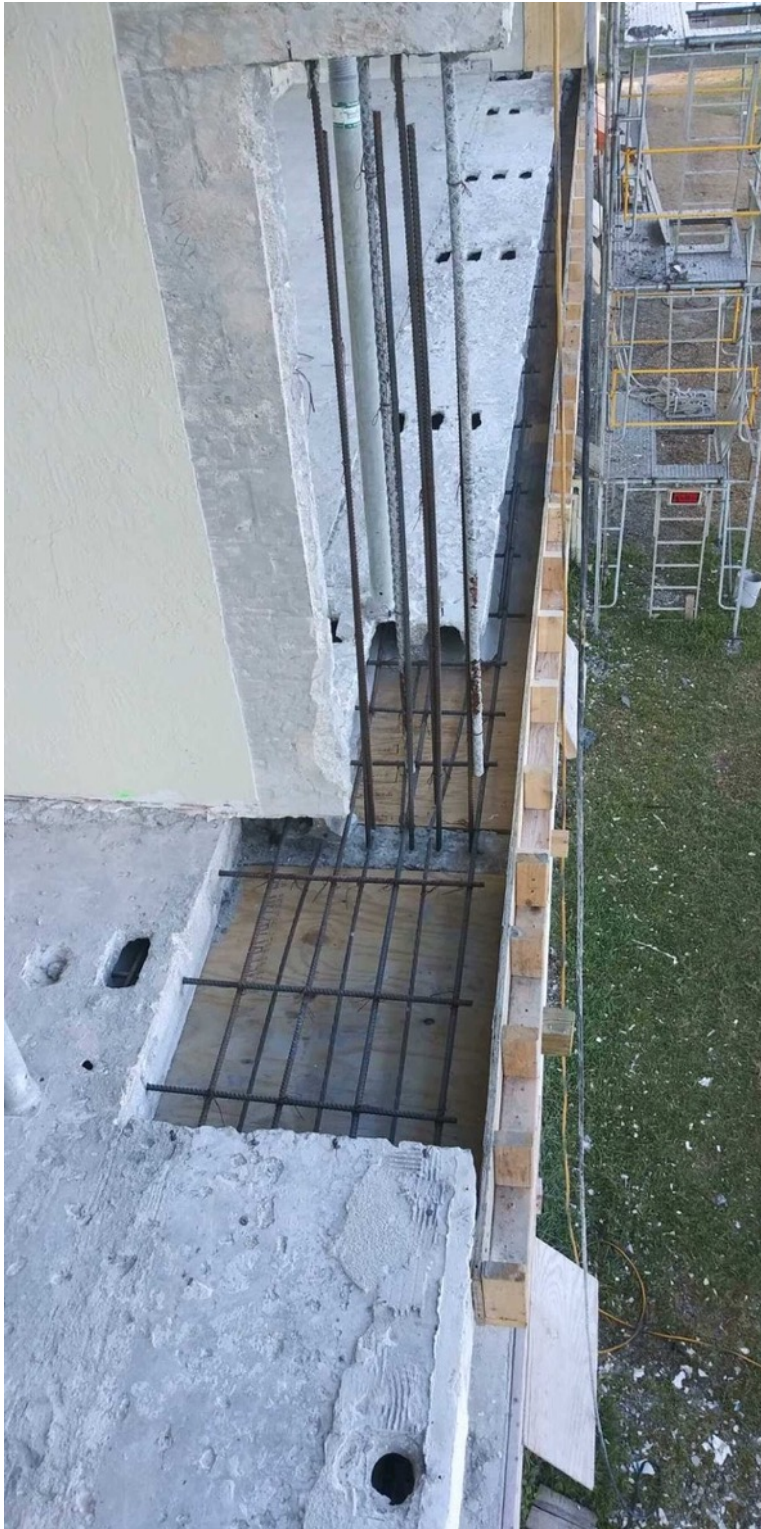
On the 403 building Unit 222/223 divider wall column, reinforcing steel was installed using #5 rebar tied-into existing steel and doweled-in/epoxy set through hollow-core slabs into the column below. Reinforcing steel was also set on the Unit 222/223 hollow-core slab edge repair using #5 rebar set north-south in hollow-core cells extending 4' beyond the repair; east-west reinforcing steel was set using #4 rebar every 24" on-center, doweled-in/epoxy set. Formwork was in-progress late in the week on the Unit 222/223 slab edge repair with casting scheduled for next week.

View of reinforcing steel set with formwork in-progress on the Unit 222/223 column and slab edge repair

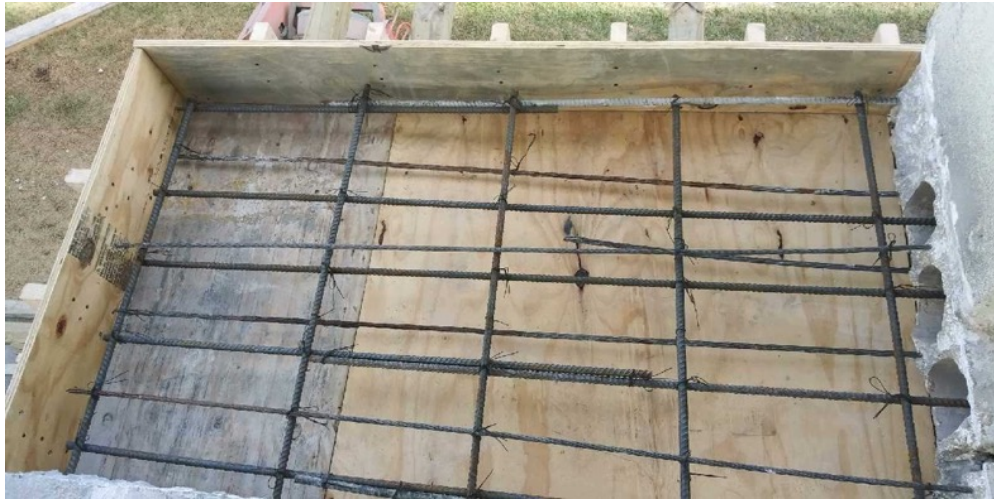
**View of forms constructed with reinforcing steel set on the Unit 211 northeast corner**

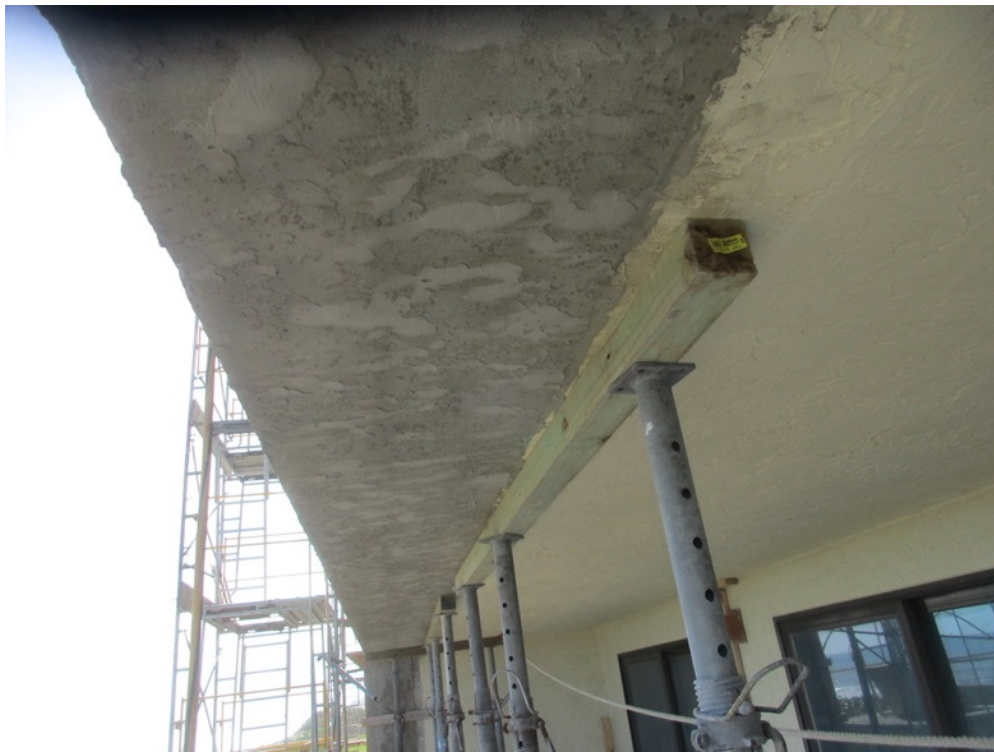
**View of stucco finish applied on the Unit 221 slab edge**

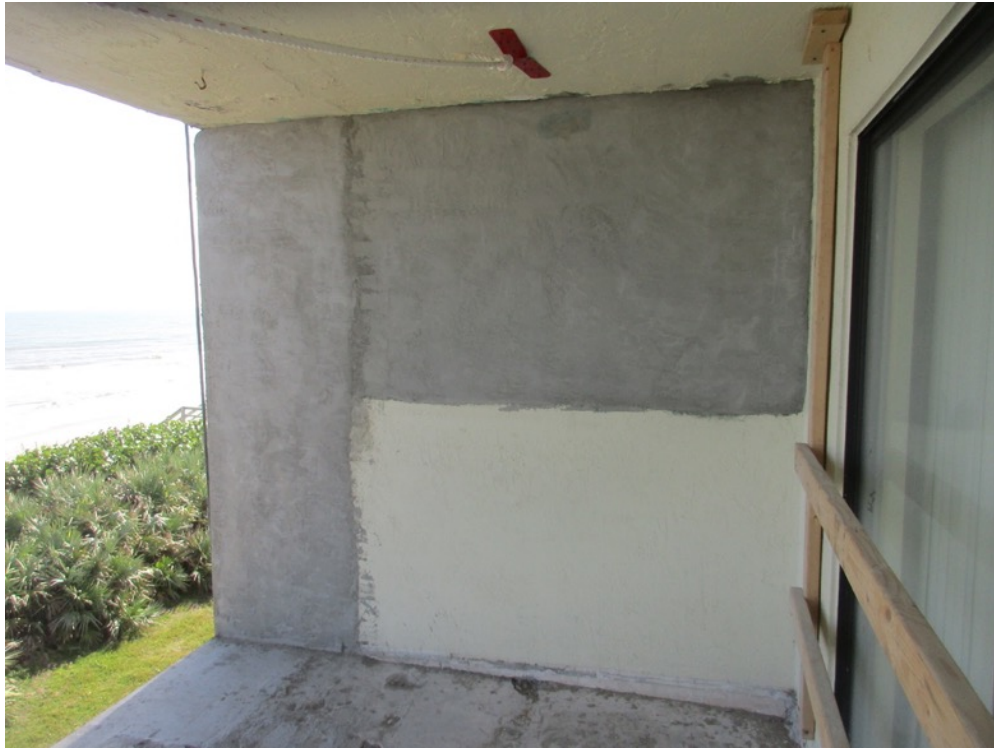
View of stucco finish applied to repaired areas on the Unit 222 south wall

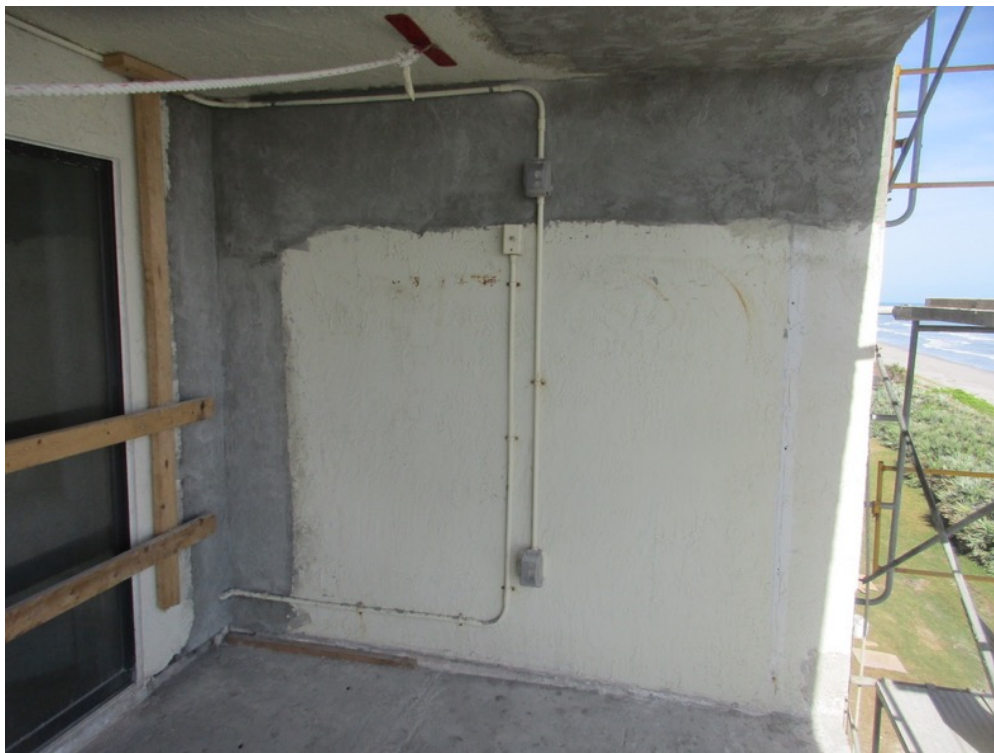
View of stucco finish applied to repaired areas on the Unit 232 north wall

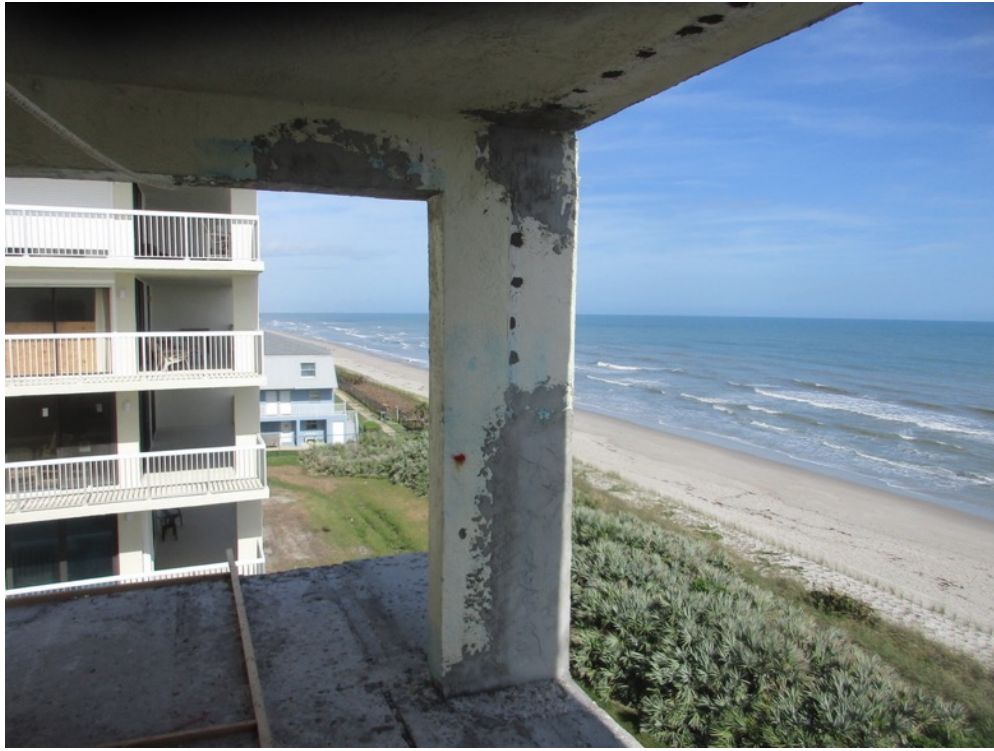
View of stucco finish applied to column repair on the Unit 241 balcony
