**Progress Inspection Report #39**  
**Permit # 18BC03039**

Project Name: East Horizon  
Project Address: 401 Highway A1A, Satellite

Progress Report thru 12-14-18  
Inspection Visits: 12-10 thru 12-13-18

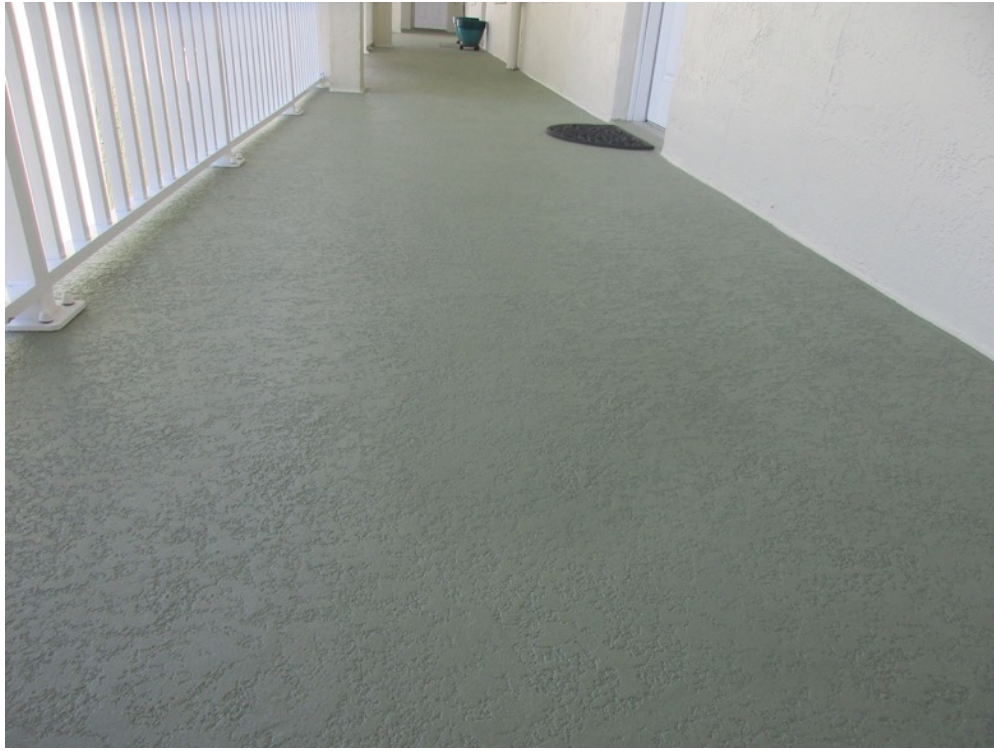
View of deck coats/cut-ins completed on the 401 building 5<sup>th</sup> floor walkway

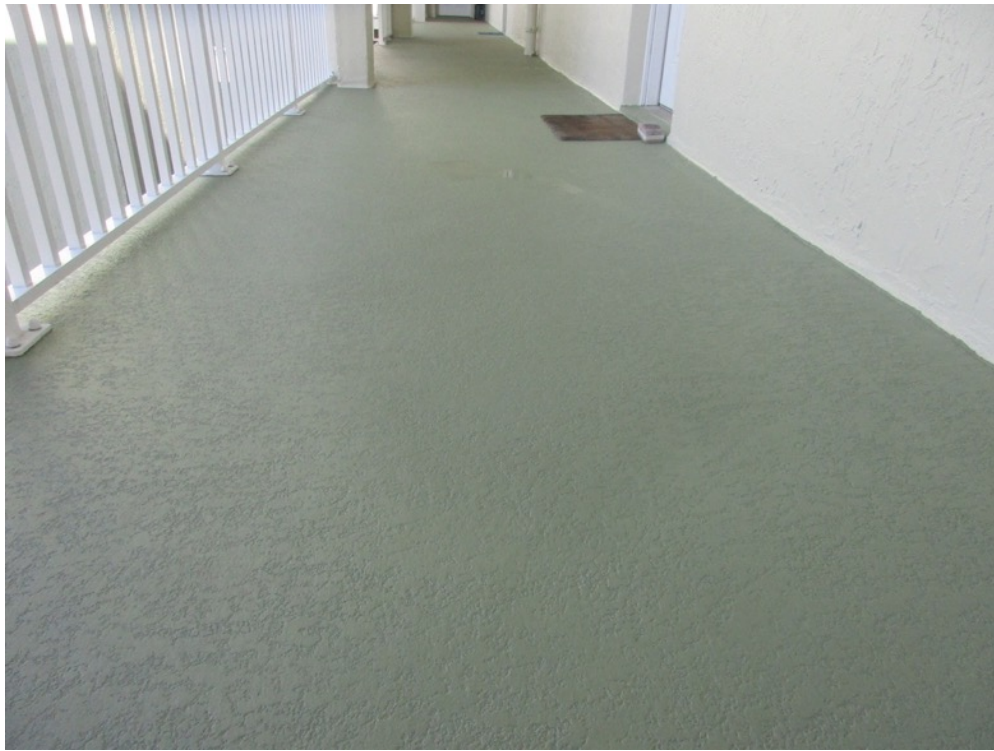
View of deck coats/cut-ins completed on the 401 building 4<sup>th</sup> floor walkway

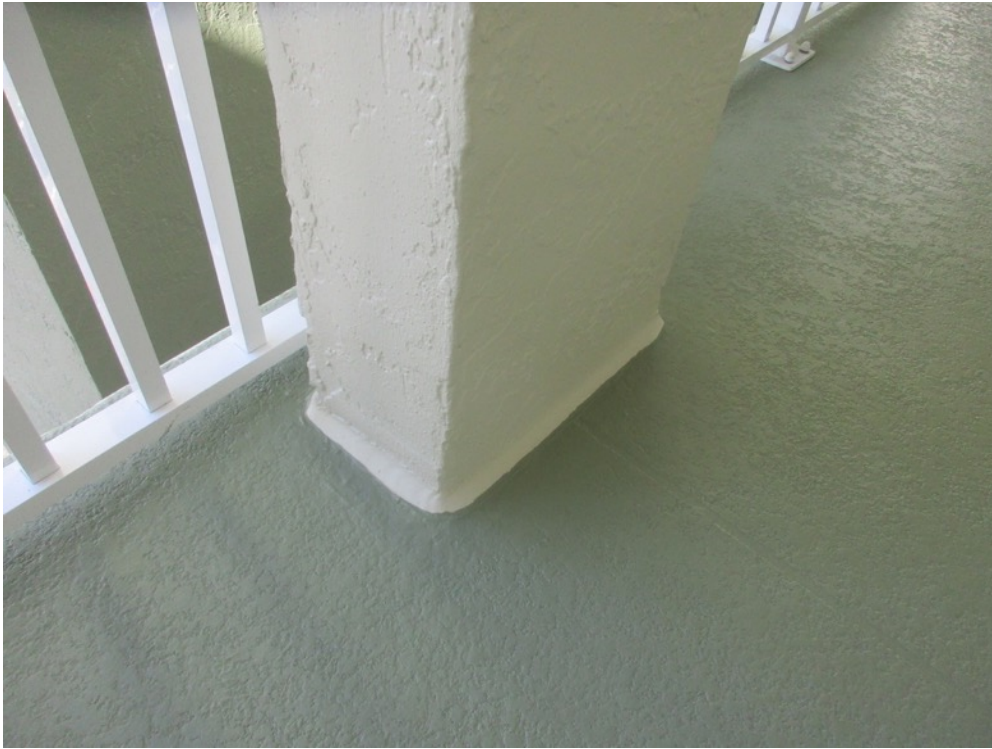
View of polyurethane cant bead tooled to column perimeter with cut-in completed on the 4<sup>th</sup> floor walkway

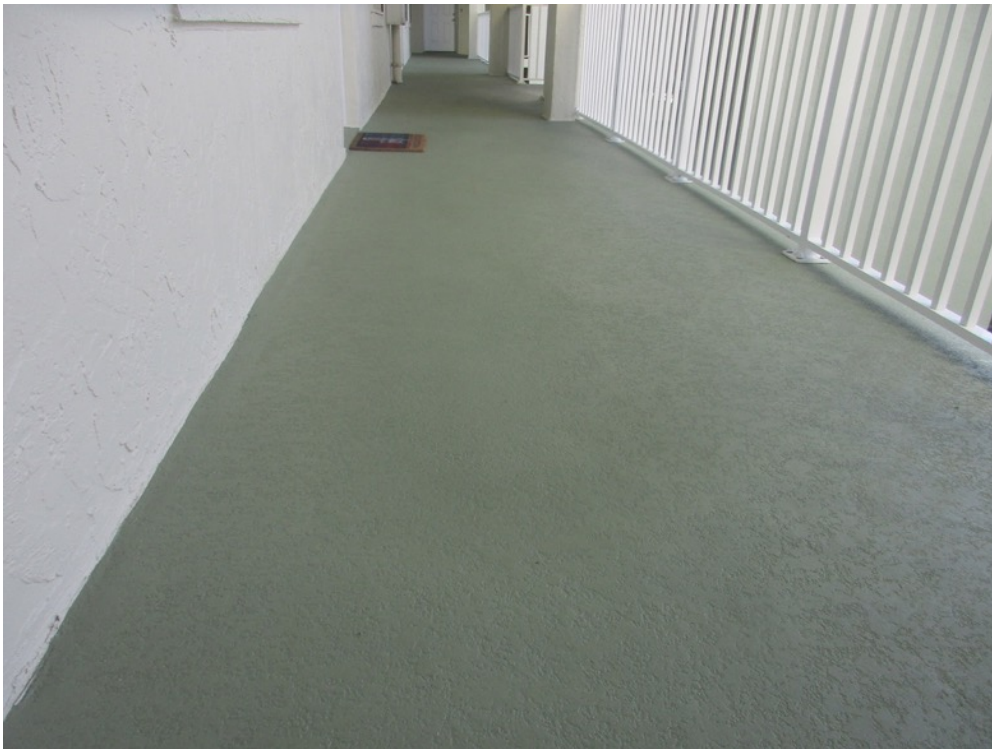
View of deck coats/cut-ins completed on the 401 building 3<sup>rd</sup> floor walkway

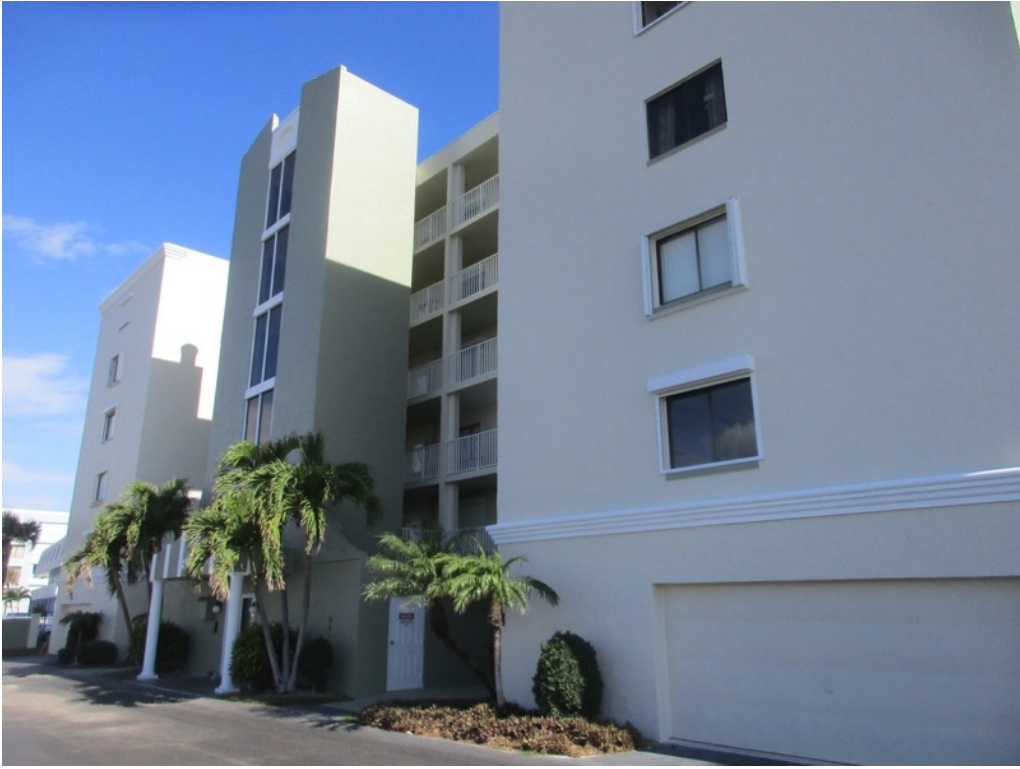
View of coatings applied to the 401 building west elevation

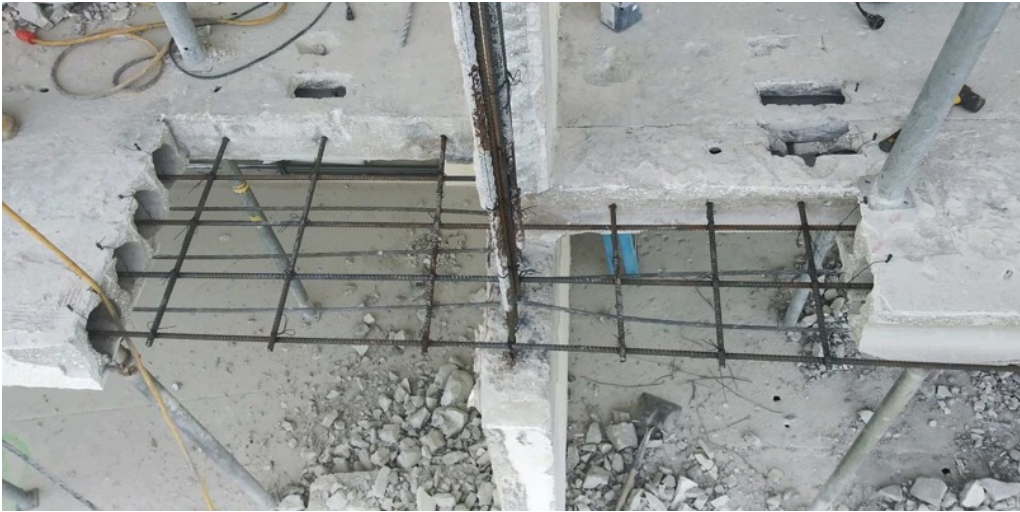
Excavations were completed on the Unit 222/223 divider wall column and hollow-core slab with reinforcing steel installation in-progress Friday, scheduled to continue next week. Additional excavations were also completed on the Unit 221 northeast corner slab edge in order to begin reinforcing steel installation and form construction next week.

View of excavations wrapping up on the Unit 222/223 balcony divider column and hollow-core slab with reinforcing steel placement in-progress
