KEYSTONE
ENGINEERING &
CONSULTING, INC.

Progress Inspection Report #59 **Permit # 18BC03039**

Project Name: East Horizon
Project Address: 401 Highway A1A, Satellite

Progress Report thru 5-3-19
Inspection Visits: 4-29 thru 5-2

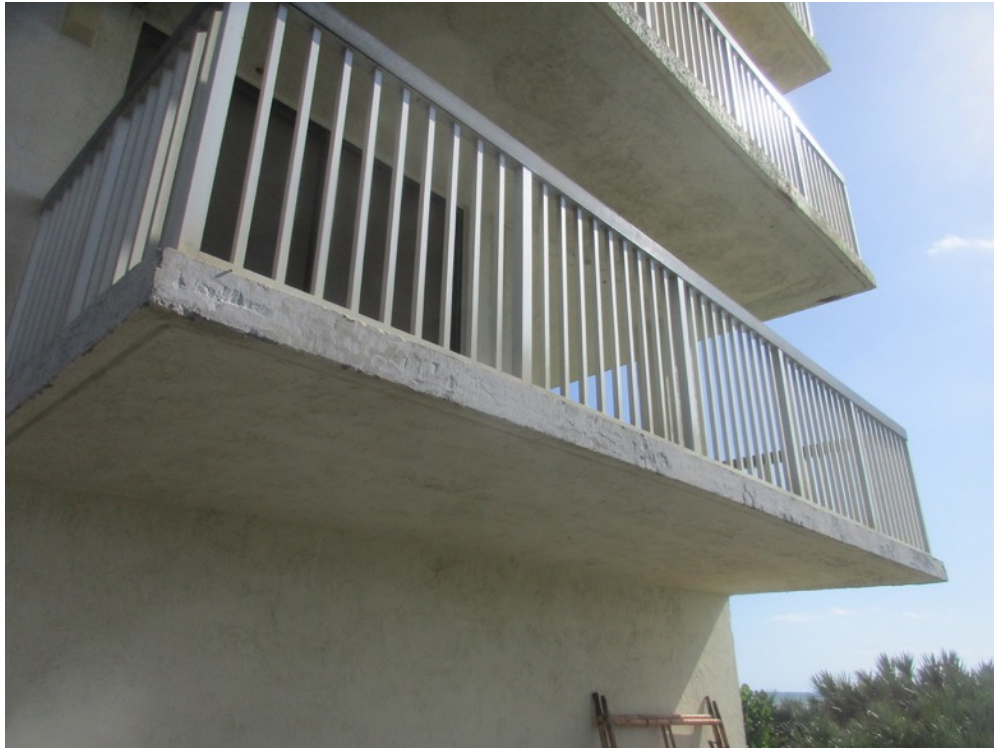
On the building 3 balconies, slab edge stucco removal has been completed on all 1st floor Units in order to expose post tension cable grout pocket locations. All post tension cable anchor locations have been covered by improper previous repairs and further excavations/slab edge stucco removal on additional floors will be required to determine post tension cable locations on the building 3 balconies.

View of stucco removed from the Unit 314 slab edge where PT grout pockets have been covered by previous repairs

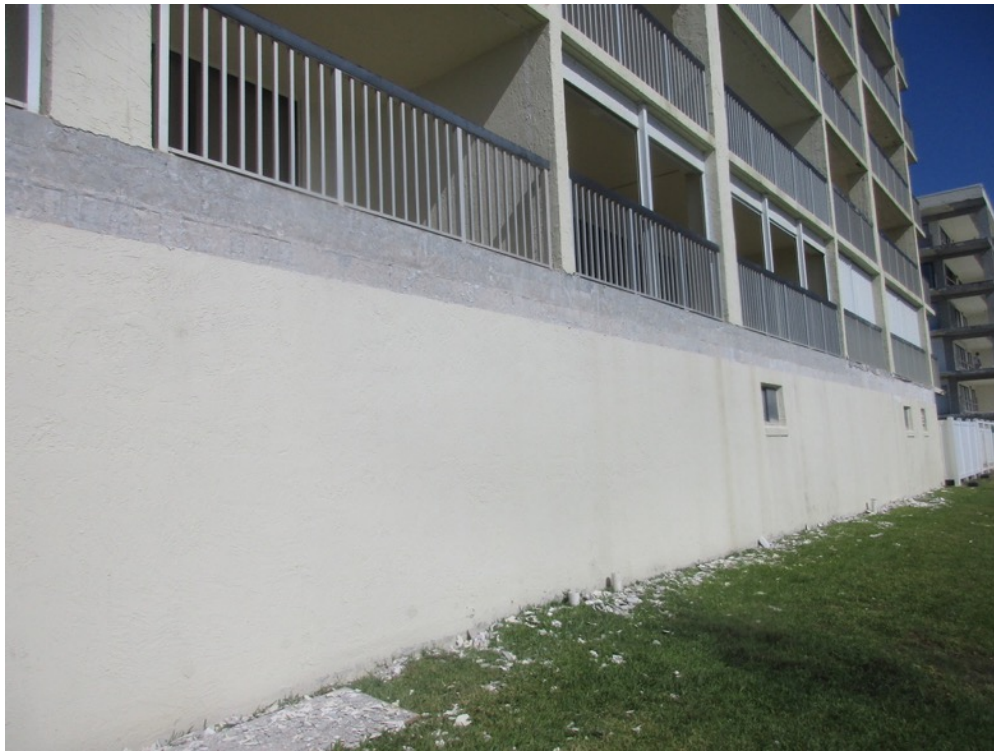
View of stucco removed from the building 3 east elevation 1st floor slab edges where PT grout pockets have been covered by previous repairs

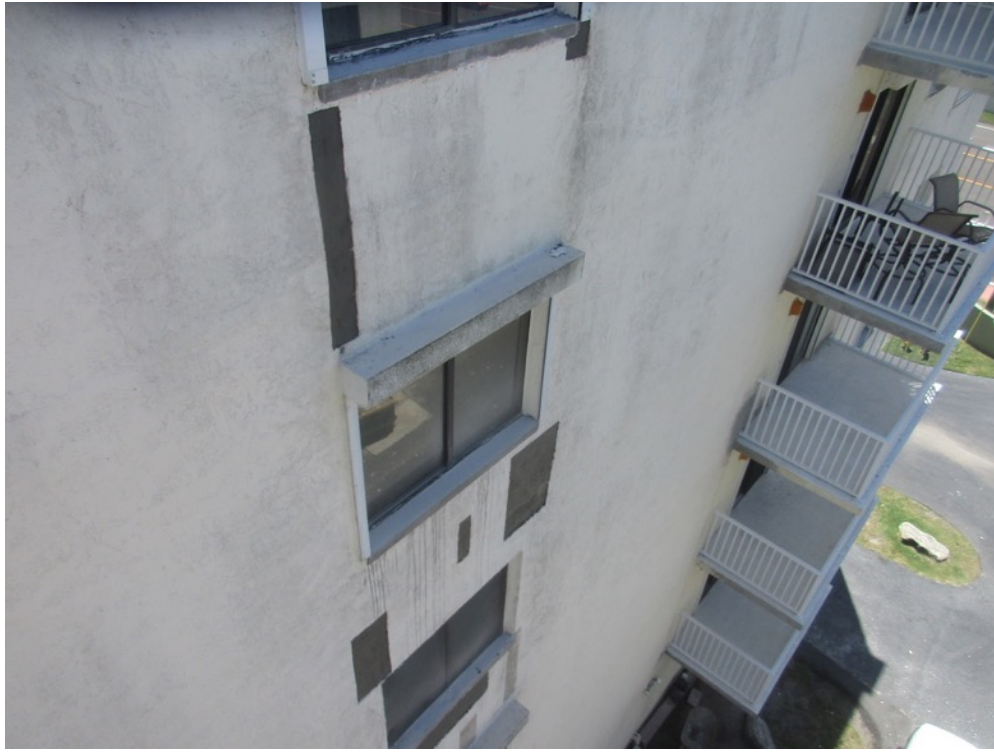
View of delaminated stucco repairs in-progress on the north elevation shearwall

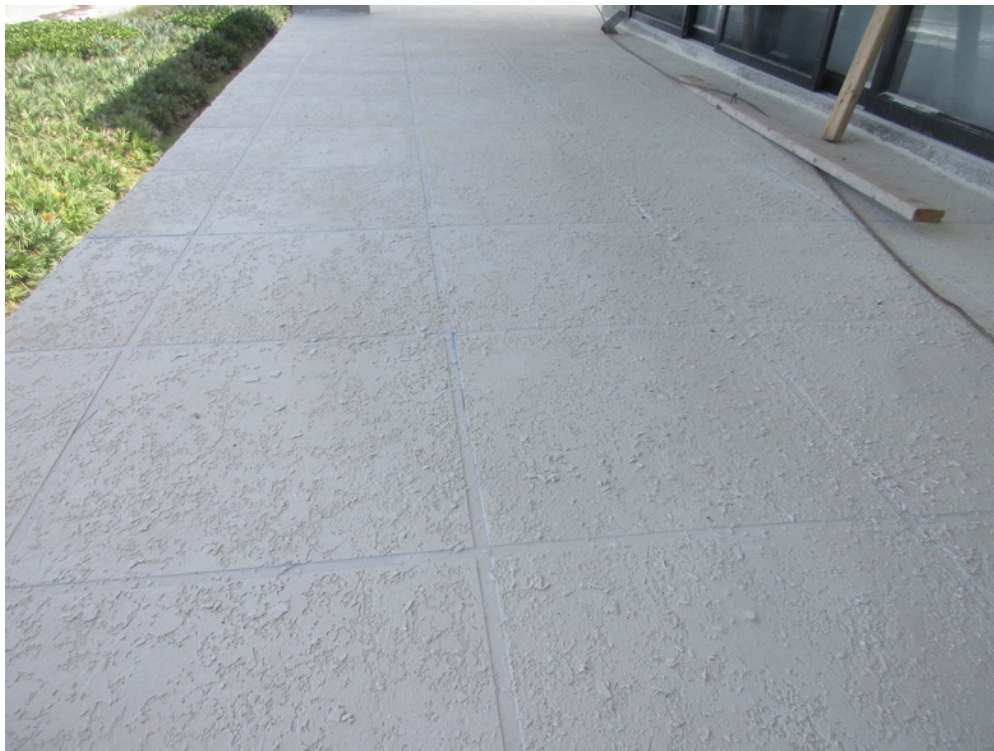
On the 04 stack southeast corner balconies, tile pattern knockdown texture application was completed on Units 224 and 234 and final surface preparation sanding is now in-progress in order to begin applying waterproofer deck coats. Knockdown texture is scheduled for completion next week on the Unit 214 balcony. Delaminated stucco and windowsill repairs are wrapping up on the north elevation shearwall and stucco finish application was finished on the west elevation walkways at slab edge/column junctures.

View of knockdown texture applied on the Unit 234 balcony deck with surface preparation sanding in-progress

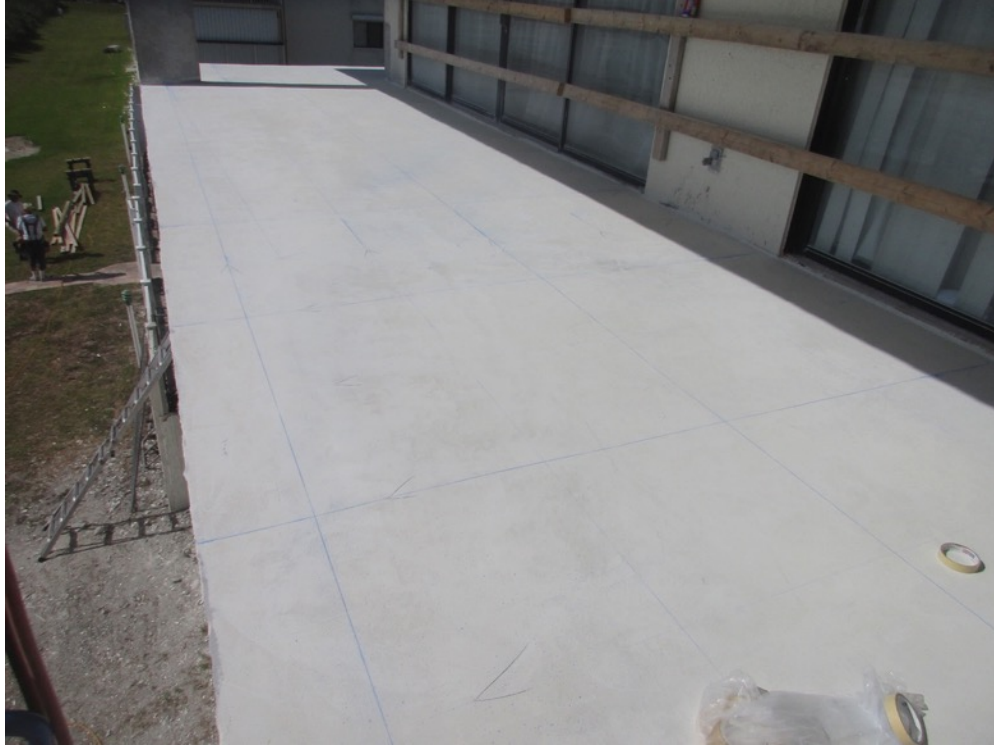
View of tile pattern grout line taping in-progress on the Unit 224 balcony deck

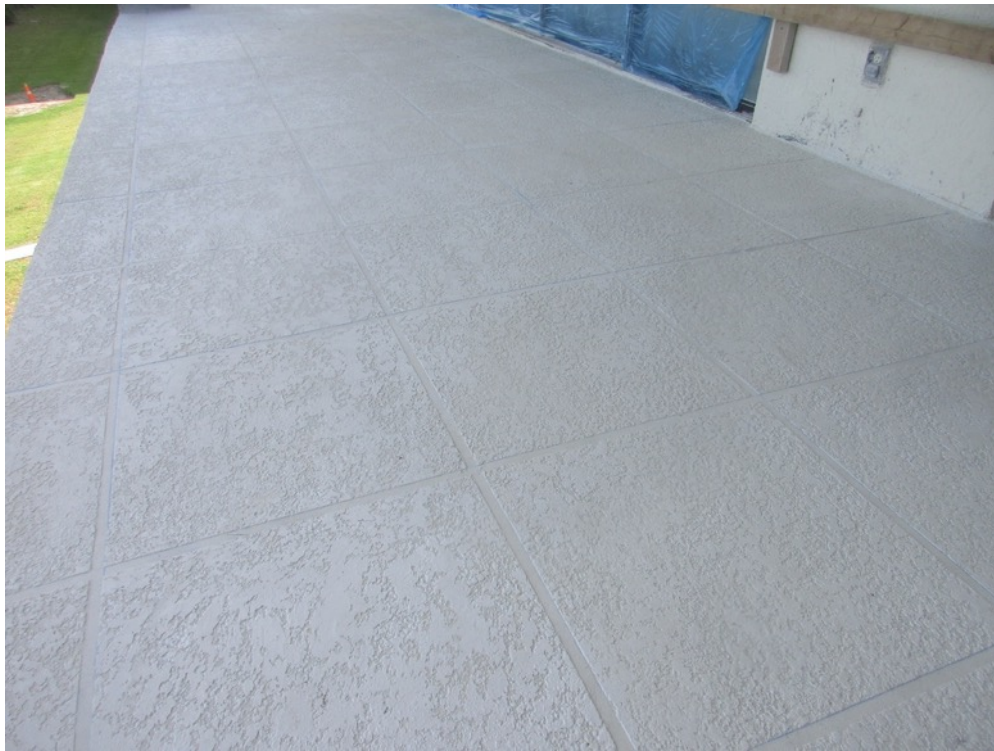
View of knockdown texture applied on the Unit 224 balcony deck

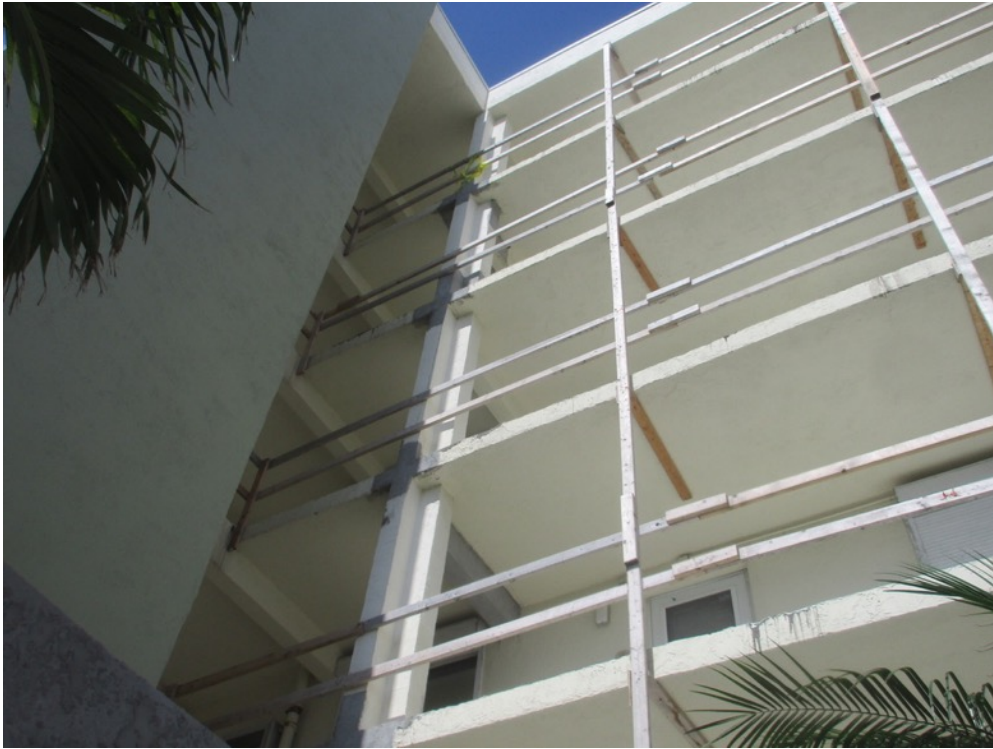
View of stucco finish applied to slab edge/column junctures on the south side walkways

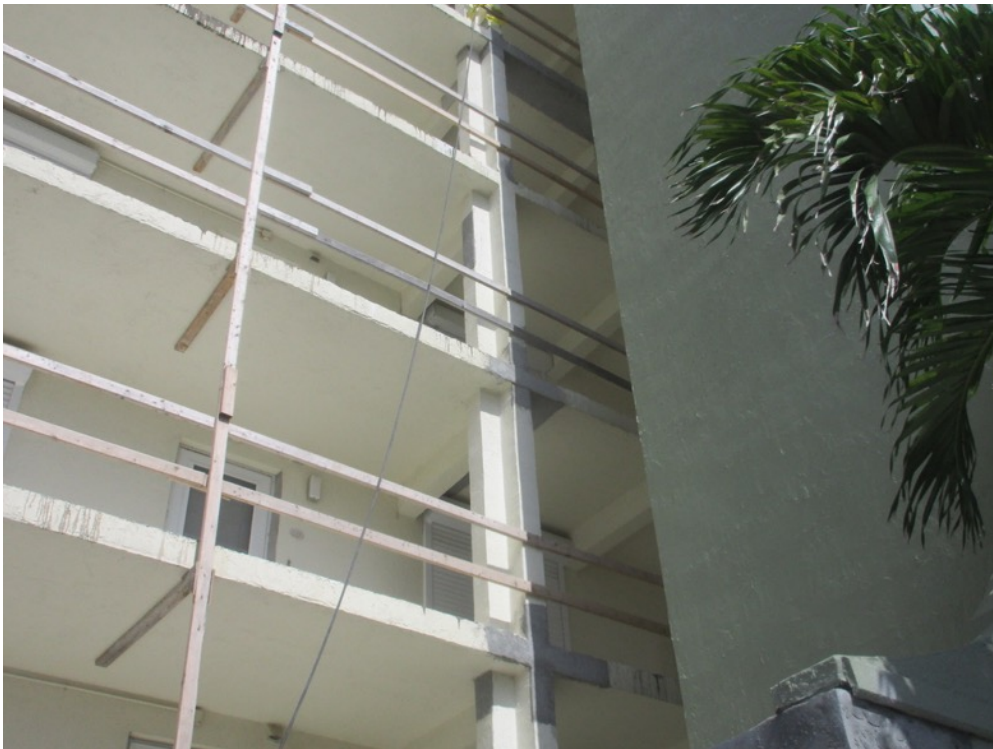
View of stucco finish applied to slab edge/column junctures on the north side walkways
