KEYSTONE
ENGINEERING &
CONSULTING, INC.

Progress Inspection Report #36
Permit # 18BC03039

Project Name: East Horizon
Project Address: 401 Highway A1A, Satellite

Progress Report thru 11-23-18
Inspection Visits: 11-19, 11-20, 11-21-18

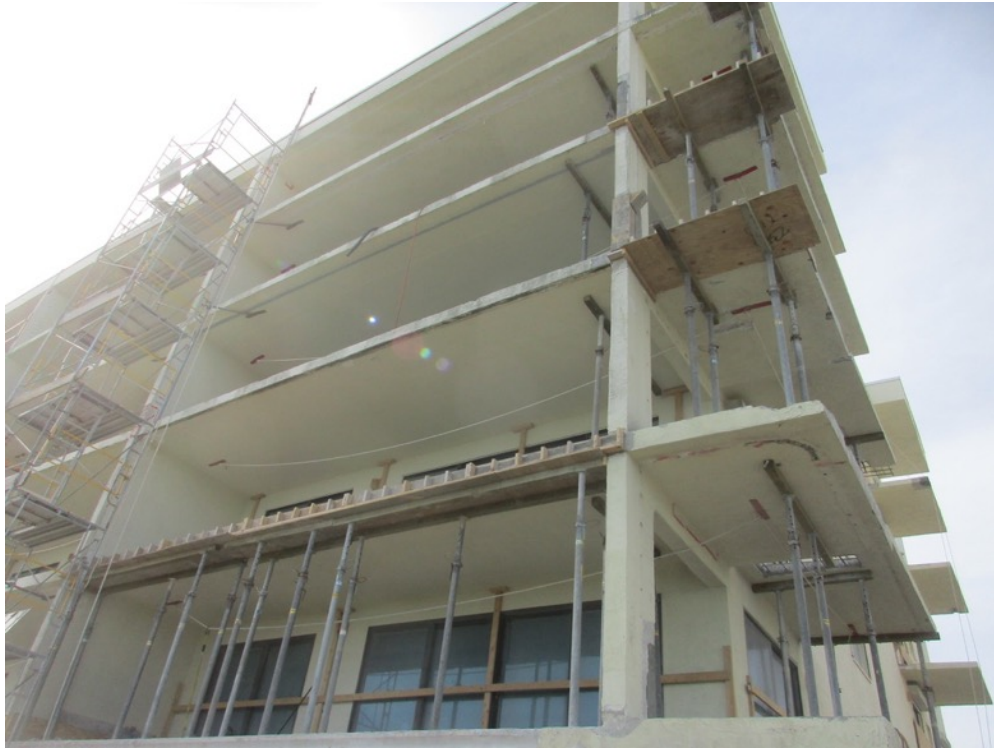
View of form construction in-progress on the 403 building 01 stack

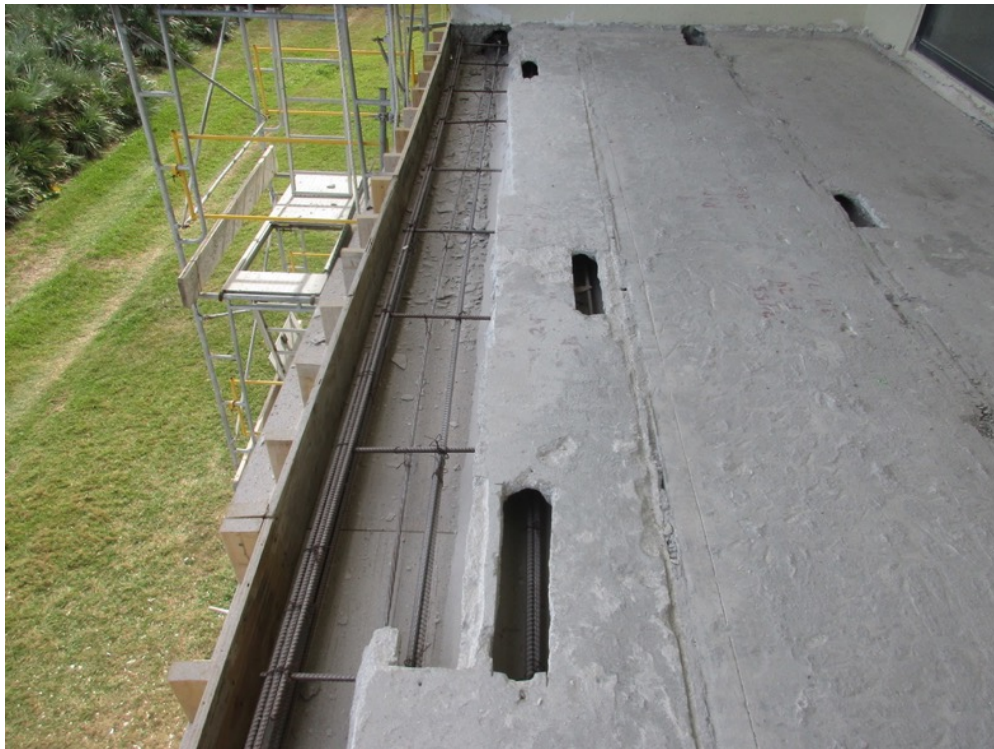
View of reinforcing steel placement in-progress on the Unit 221 balcony slab edge repair

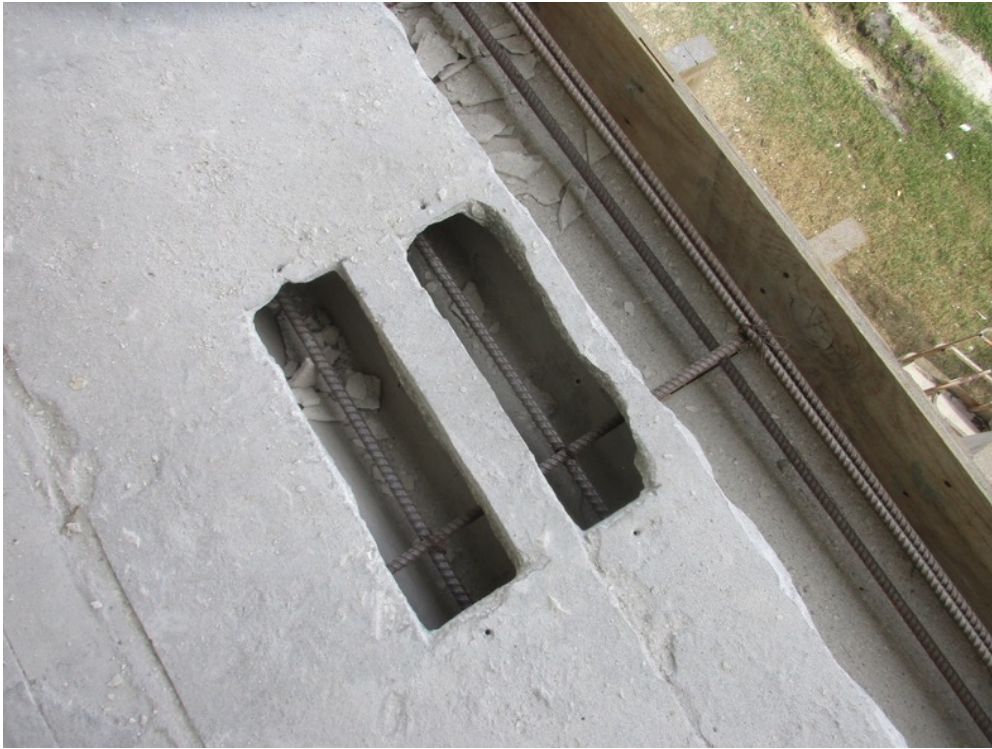
View showing #5 rebar set north-south in hollow-core cells on the Unit 221 balcony slab edge repair with east-west #4 rebar tied in

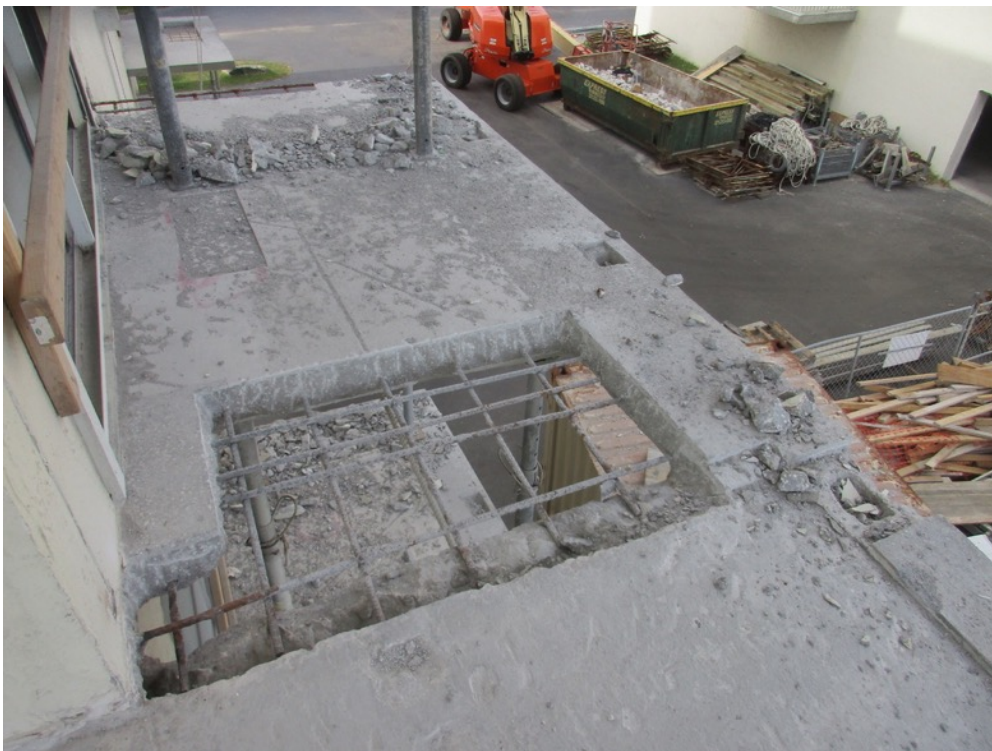
View of full depth excavations in-progress on the Unit 221 corner balcony north elevation

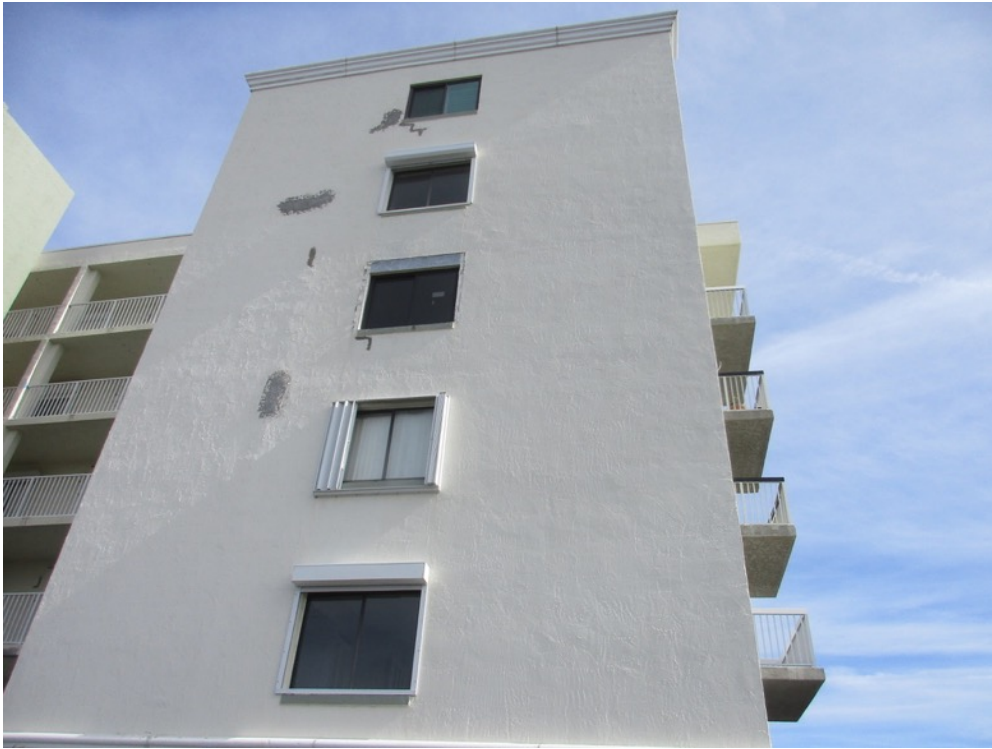
View of stucco repairs completed on the 401 building west elevation shearwall south end

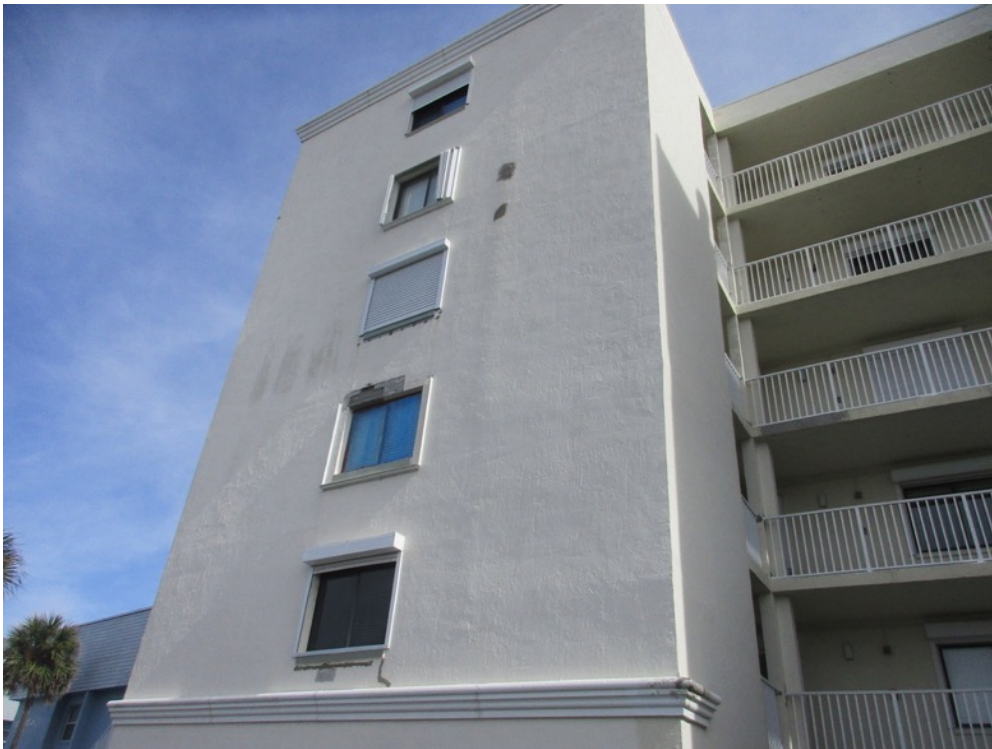
View of window header and stucco repairs completed on the 401 building west elevation shearwall north end
