Progress Inspection Report #21 **Permit # 18BC03039**

Project Name: East Horizon
Project Address: 401 Highway A1A, Satellite

Progress Report thru 8-10-18
Inspection Visits: 8-6 thru 8-10-18

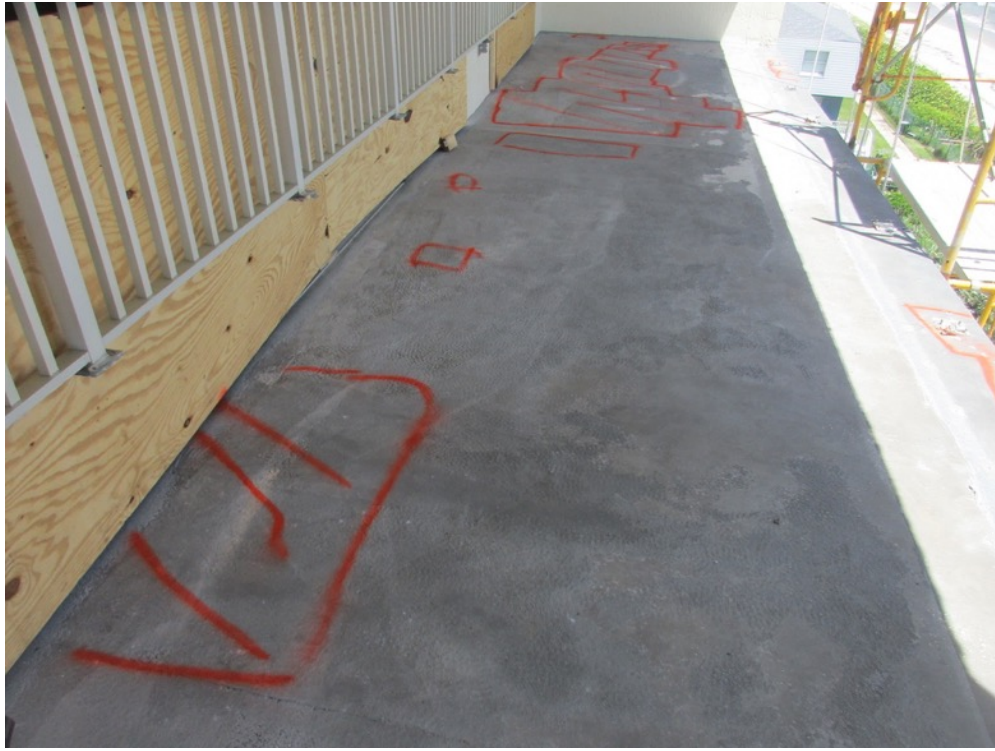
View of areas marked for repair on the Unit 154 corner balcony east elevation

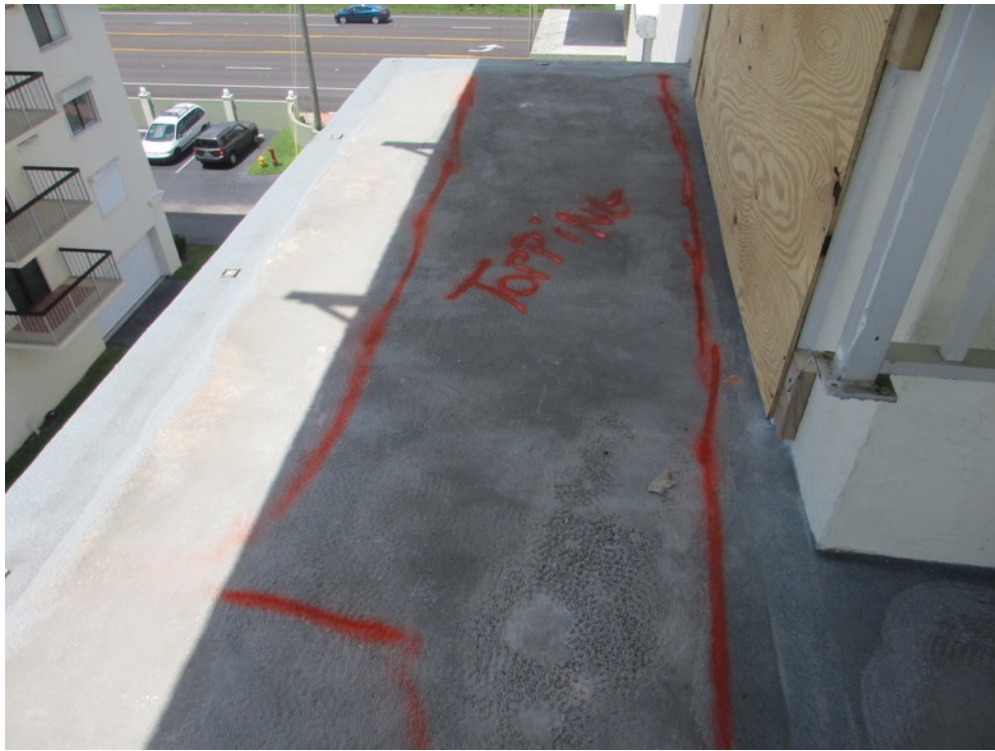
View of areas marked as likely topping repairs on the Unit 154 corner balcony south elevation

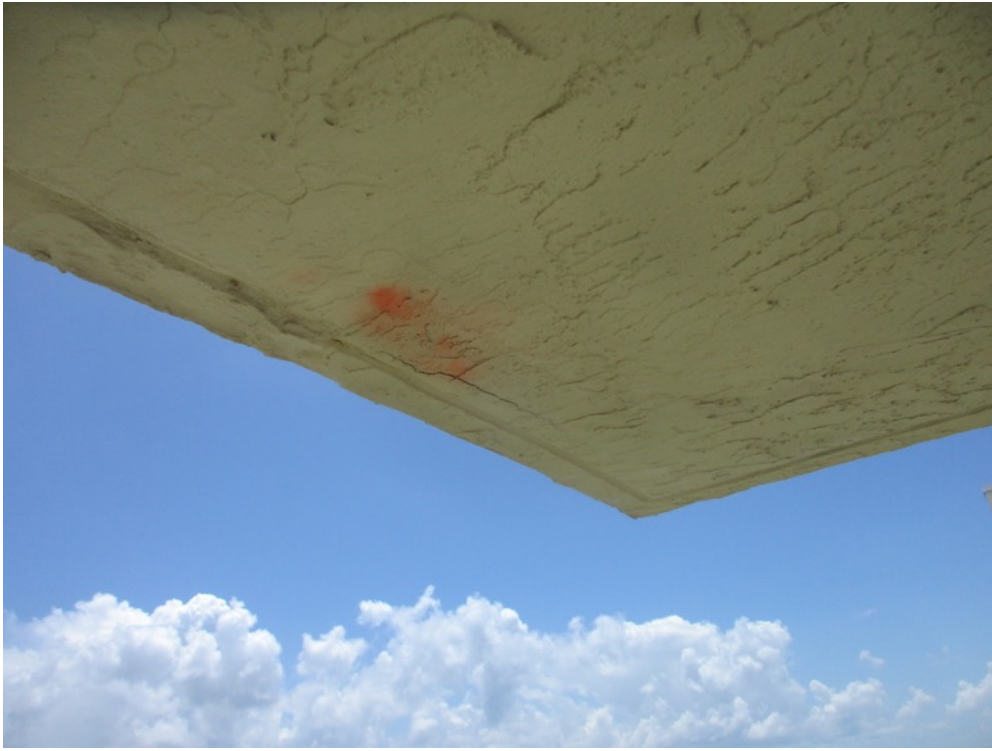
View of slab edge spall marked for repair on the Unit 144 corner balcony

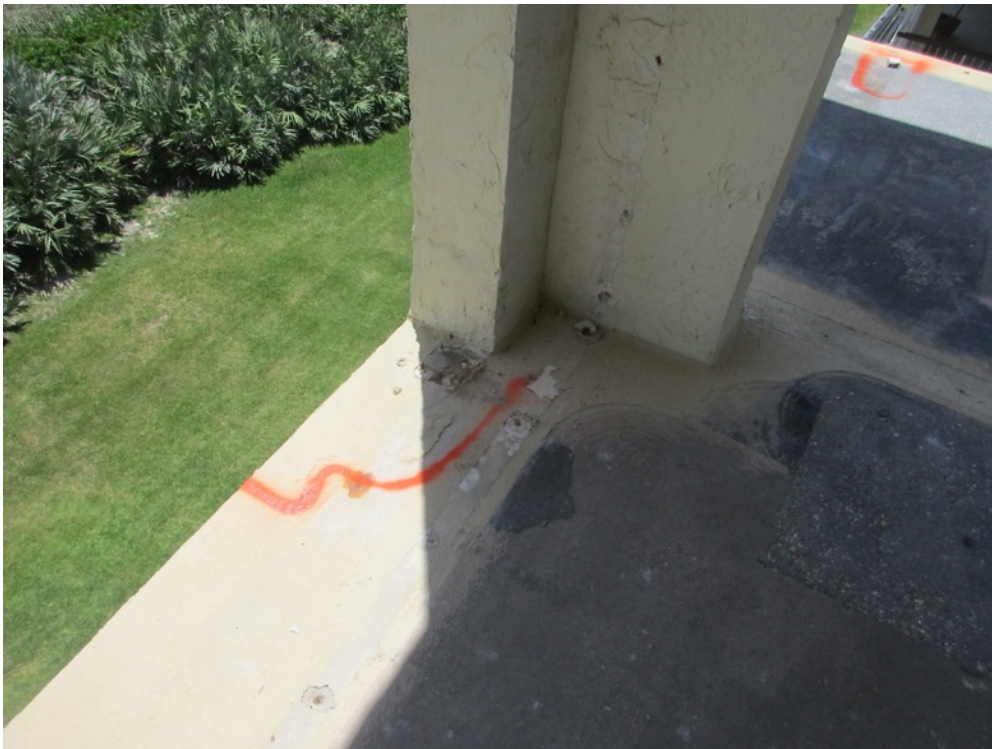
View of slab edge spall marked for repair on the Unit 134 corner balcony

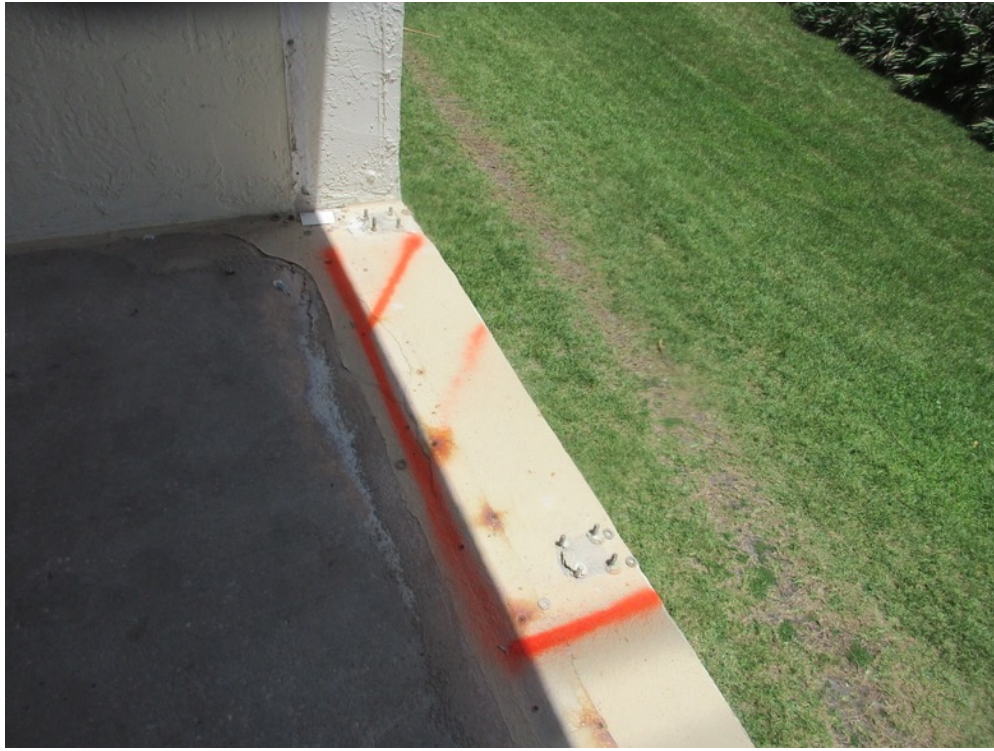
View of slab edge spall marked for repair on the Unit 114 corner balcony

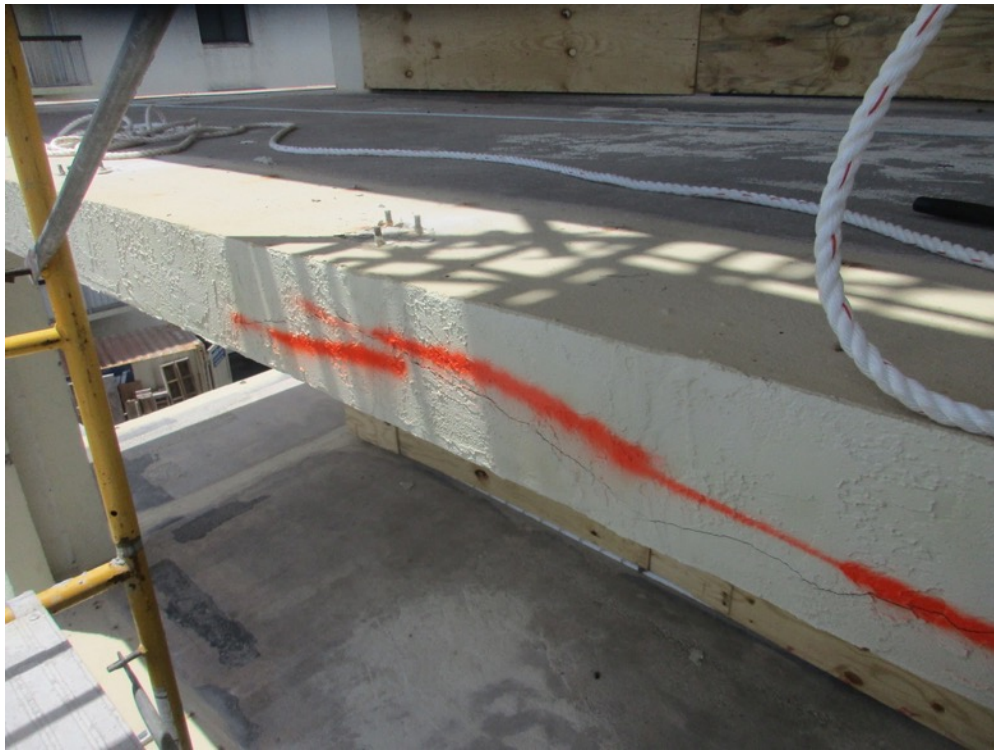
View of edge spall marked for repair on the Unit 134 balcony

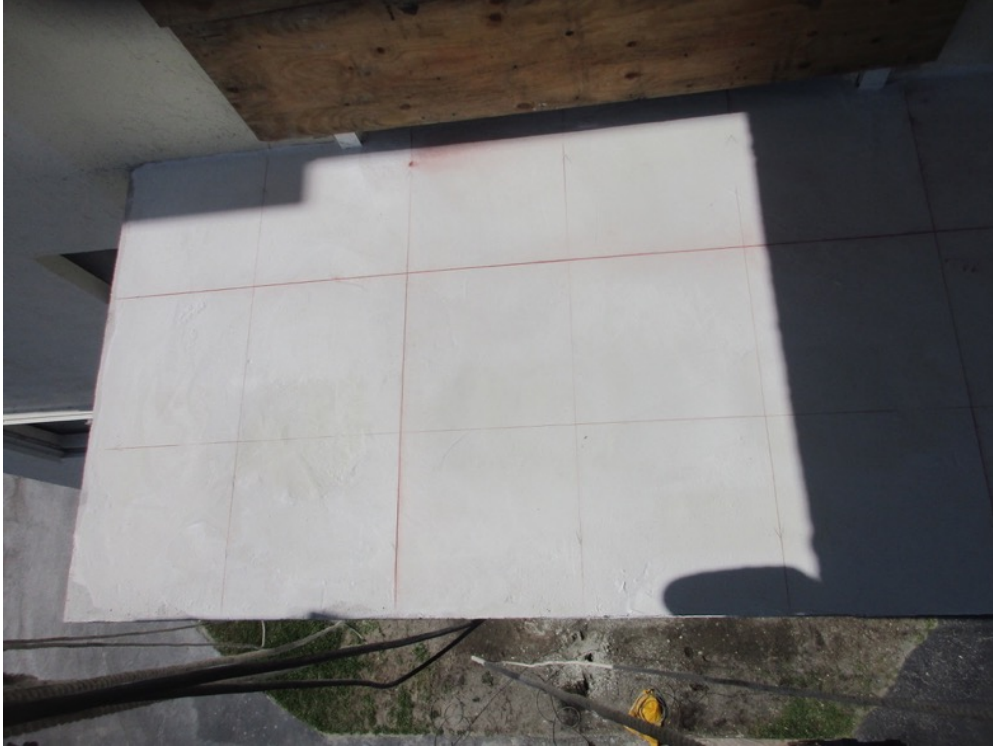
View of initial skim coat applied on the Unit 144 south side balcony

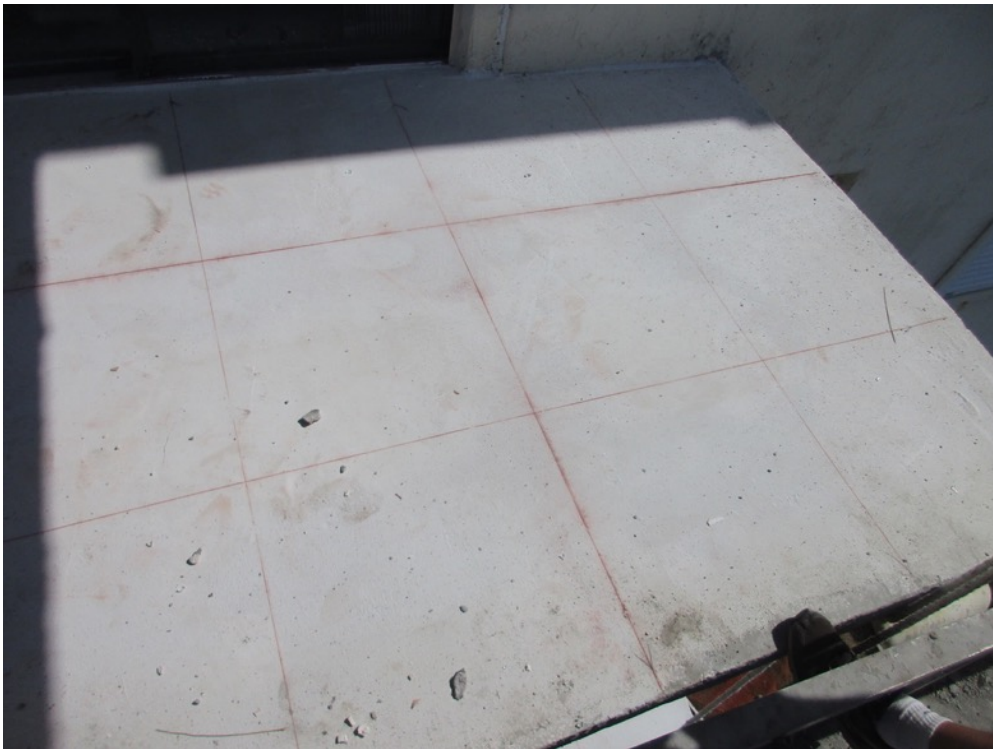
View of initial skim coat applied on the Unit 141 north side balcony
