KEYSTONE
ENGINEERING &
CONSULTING, INC.

Progress Inspection Report #45 **Permit # 18BC03039**

Project Name: East Horizon
Project Address: 401 Highway A1A, Satellite

Progress Report thru 1-25-19
Inspection Visits: 1-23, 1-24 and 1-25

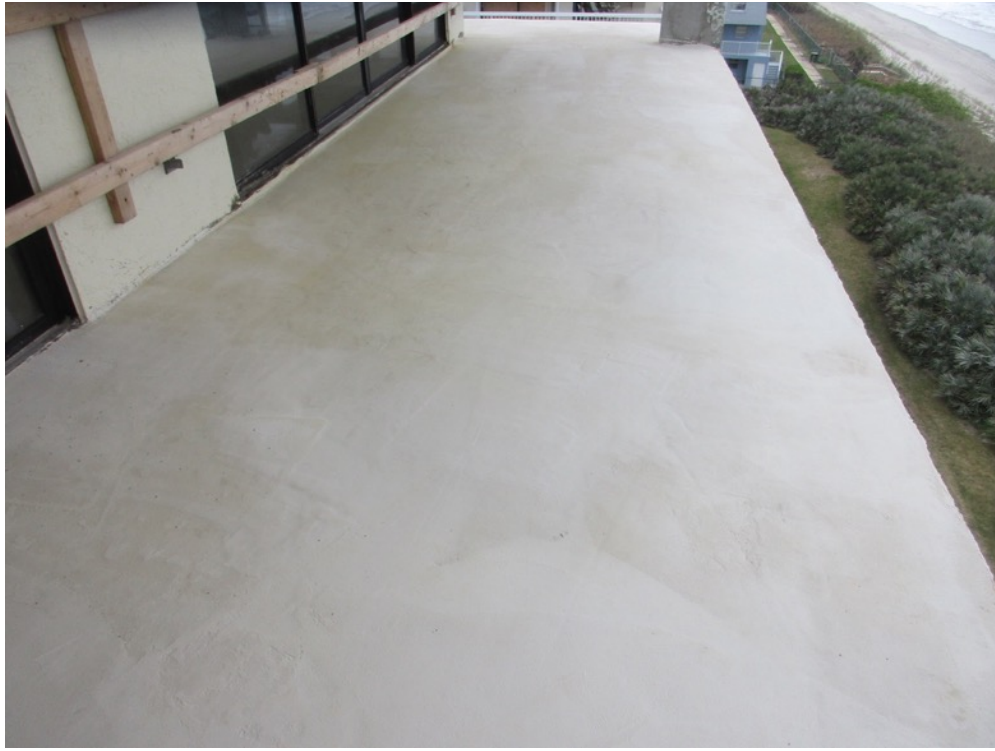
View of skim coat applied on the Unit 251 balcony east elevation

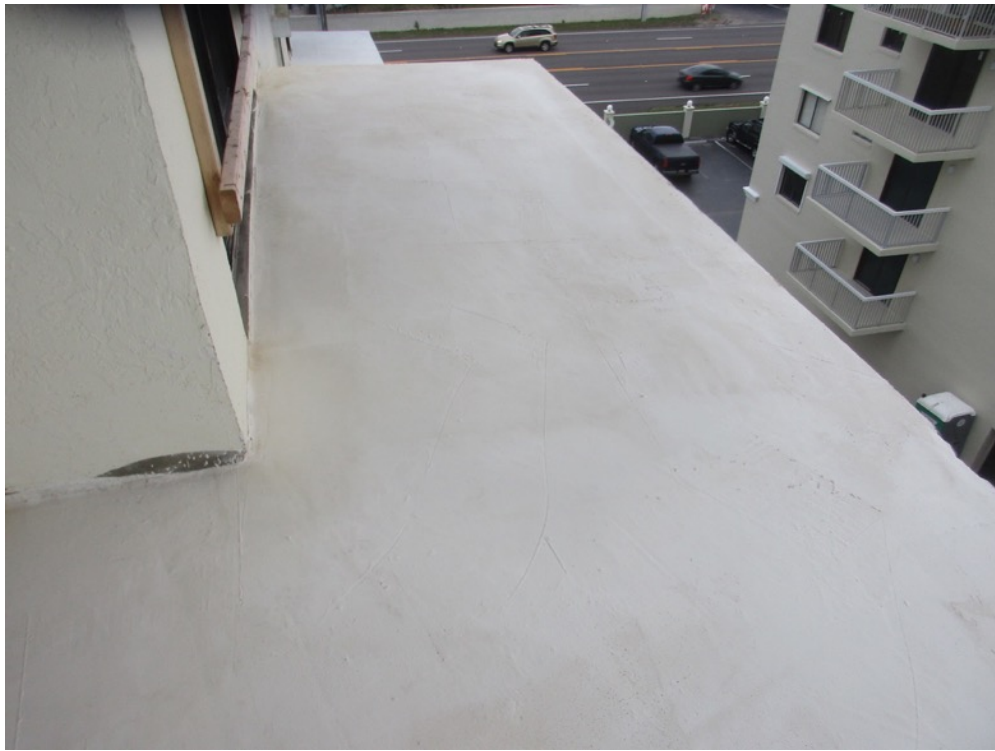
View of skim coat applied on the Unit 251 balcony north elevation

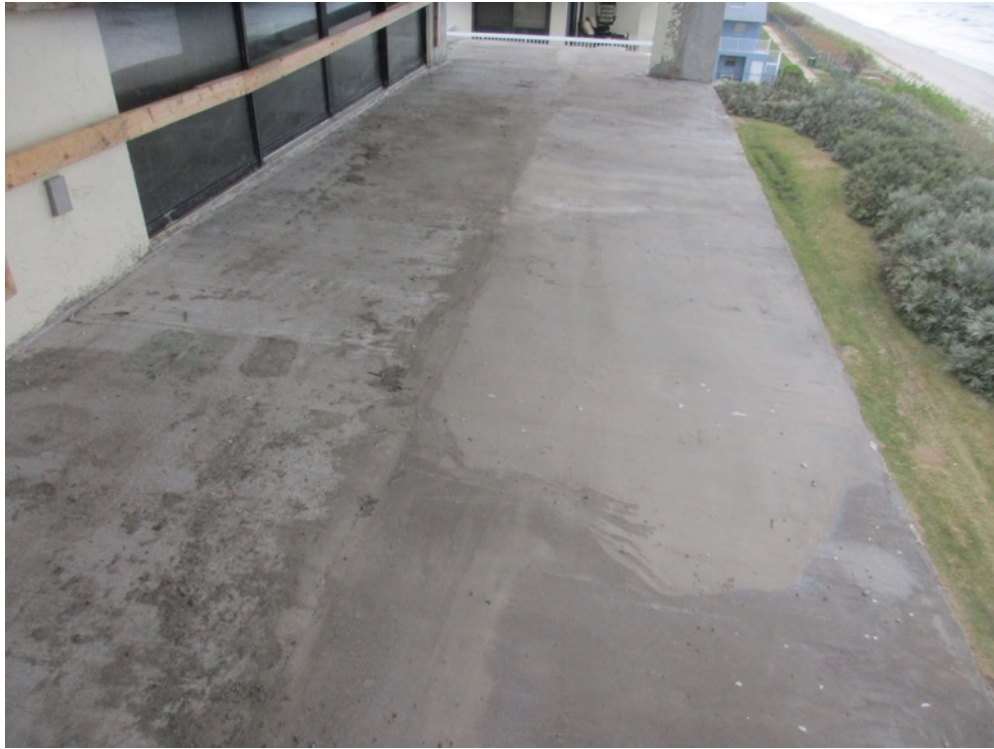
View of topping repairs cast back on the Unit 241 balcony

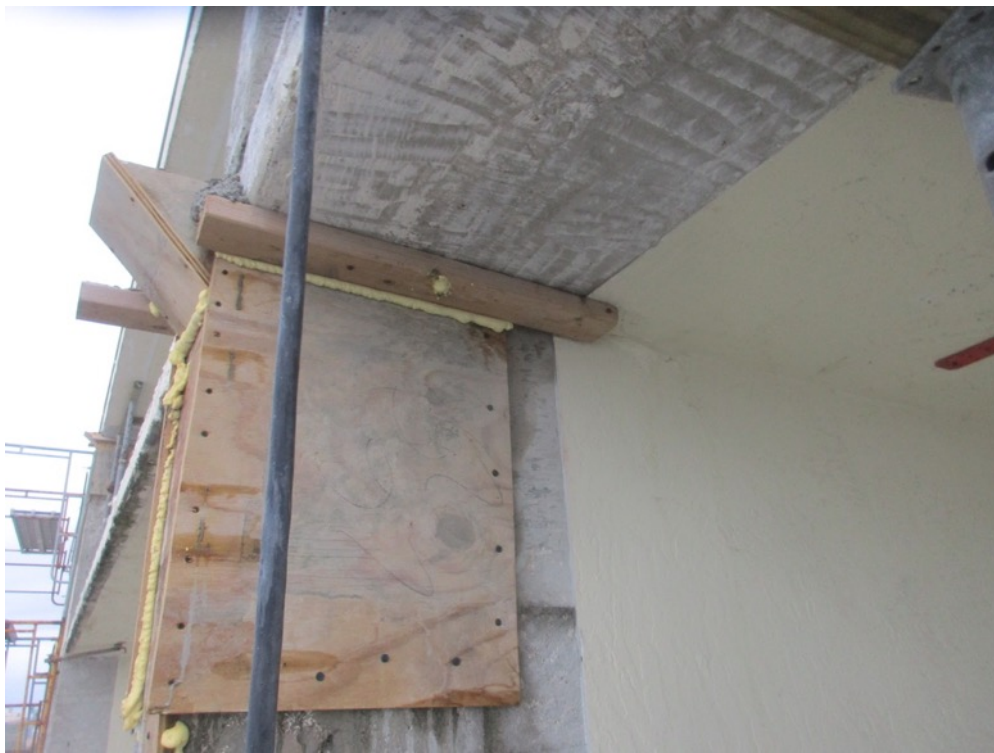
View of forms constructed with casting completed on the Unit 242/243 column repair

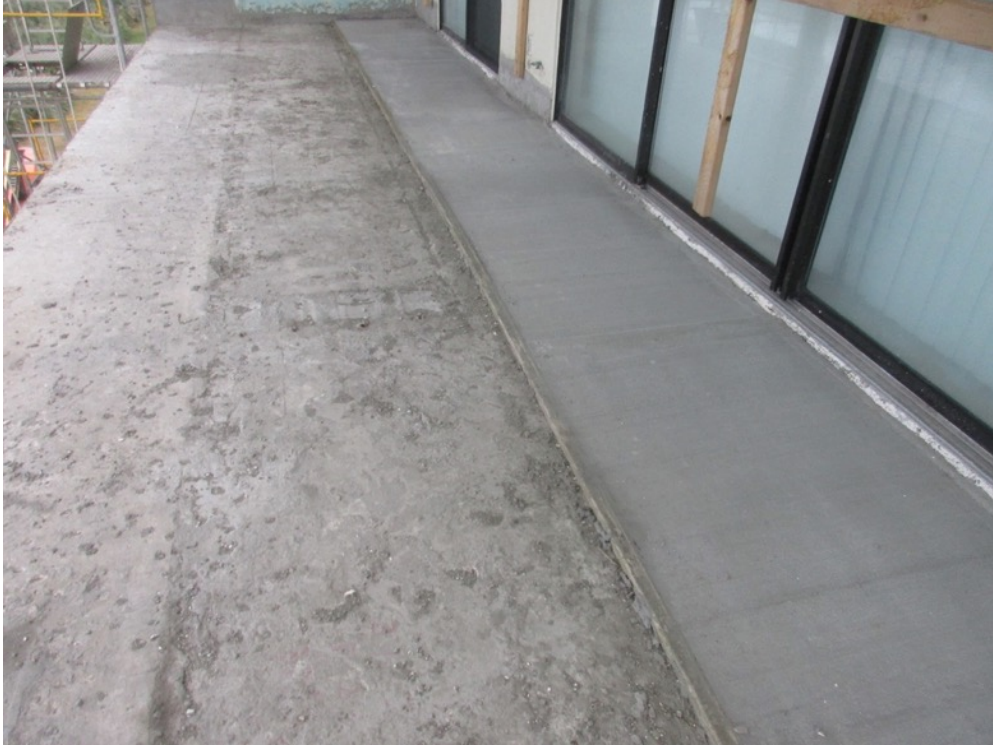
View of topping casting in-progress on the Unit 231 balcony

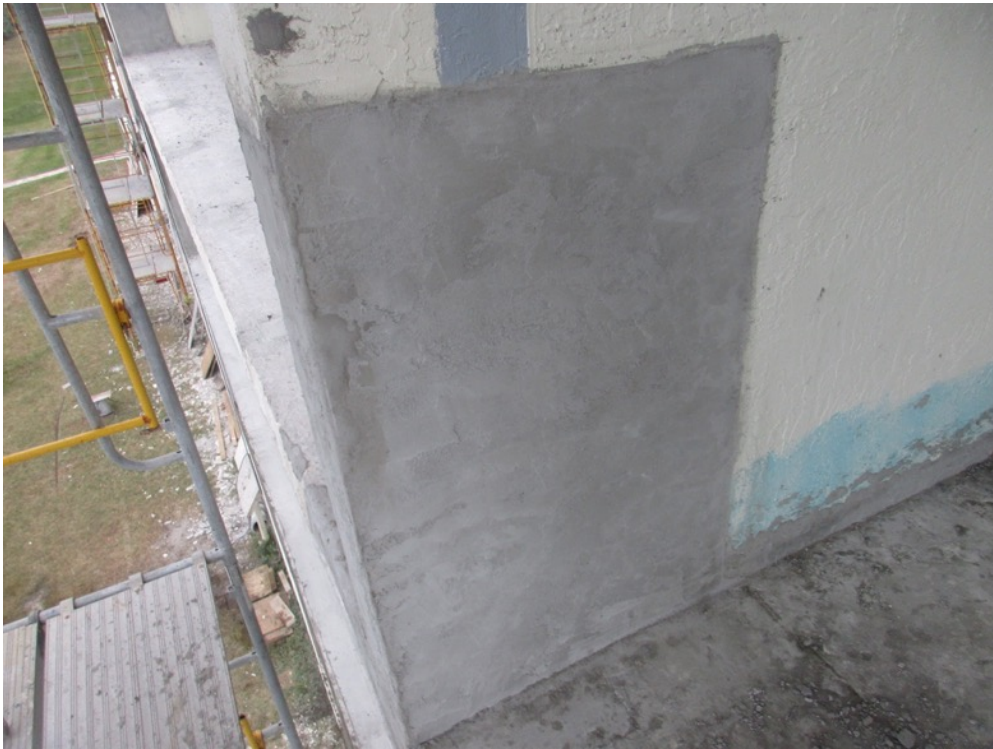
View of the Unit 231/232 column repair cast back with stucco finish applied

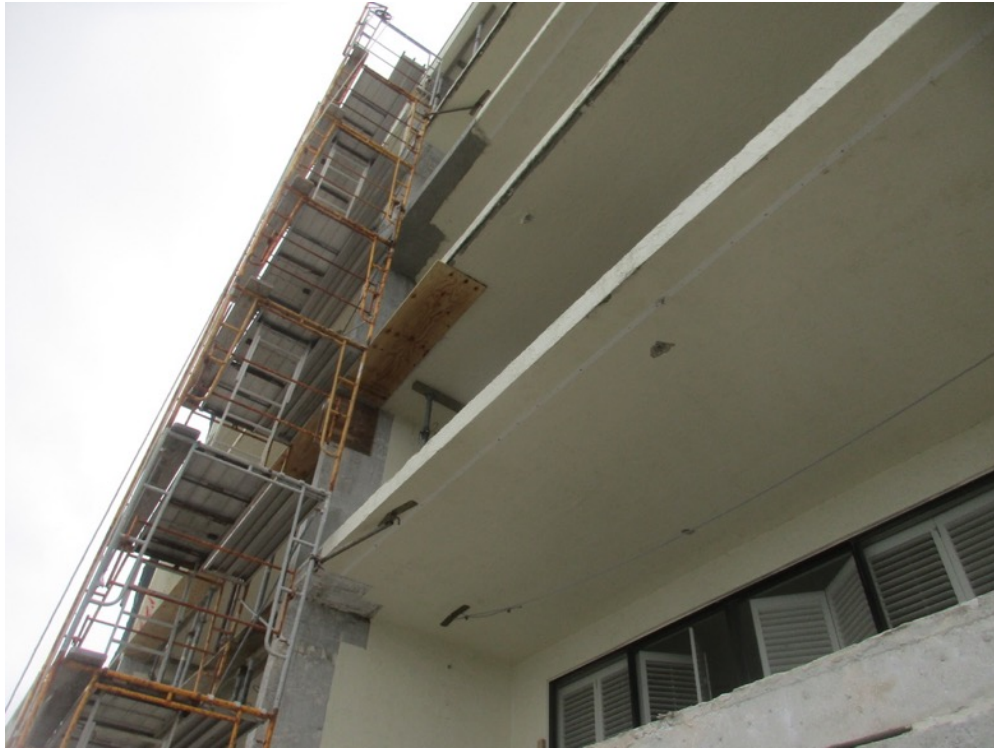
Column excavations are wrapping up on the 02/03 stack balcony divider walls and remain in-progress on the 03/04 stack divider walls; supplemental reinforcing steel is being installed using #5 rebar to tie into columns above/below and into slab edge hollow-core cells running 2' north-south.

View of column excavations in-progress on the 03/04 balcony stack divider walls
