Progress Inspection Report #64 **Permit # 18BC03039**

Project Name: East Horizon
Project Address: 401 Highway A1A, Satellite

Progress Report thru 6-7-19
Inspection Visits: 6-3 thru 6-6

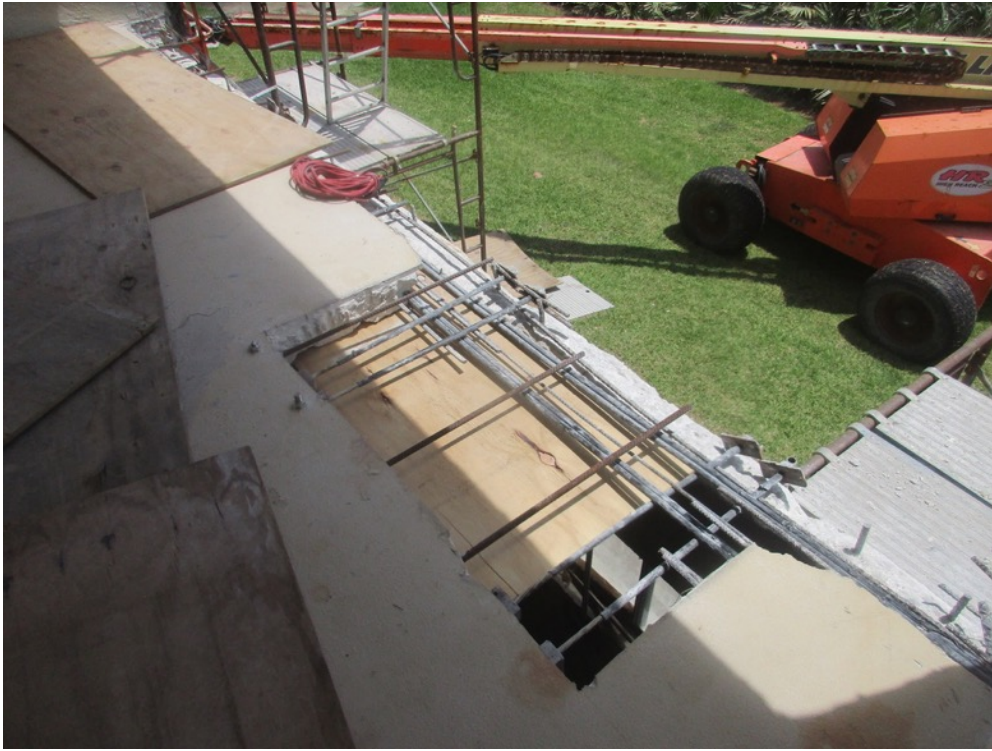
View of slab edge and full depth excavations completed with reinforcing steel install in-progress on the Unit 312 balcony north end

Slab edge and full depth excavations were finished on the Unit 311 and 312 balconies and are wrapping up on the Unit 313 balcony, scheduled to continue next Monday. East-west reinforcing steel was being set on the Unit 311, 312 and 313 balconies using #5 rebar doweled-in/epoxy set every 12" on-center and at post tension cable anchor locations. North-south bursting bar reinforcing steel was being removed/replaced using #5 rebar where corrosion was severe.

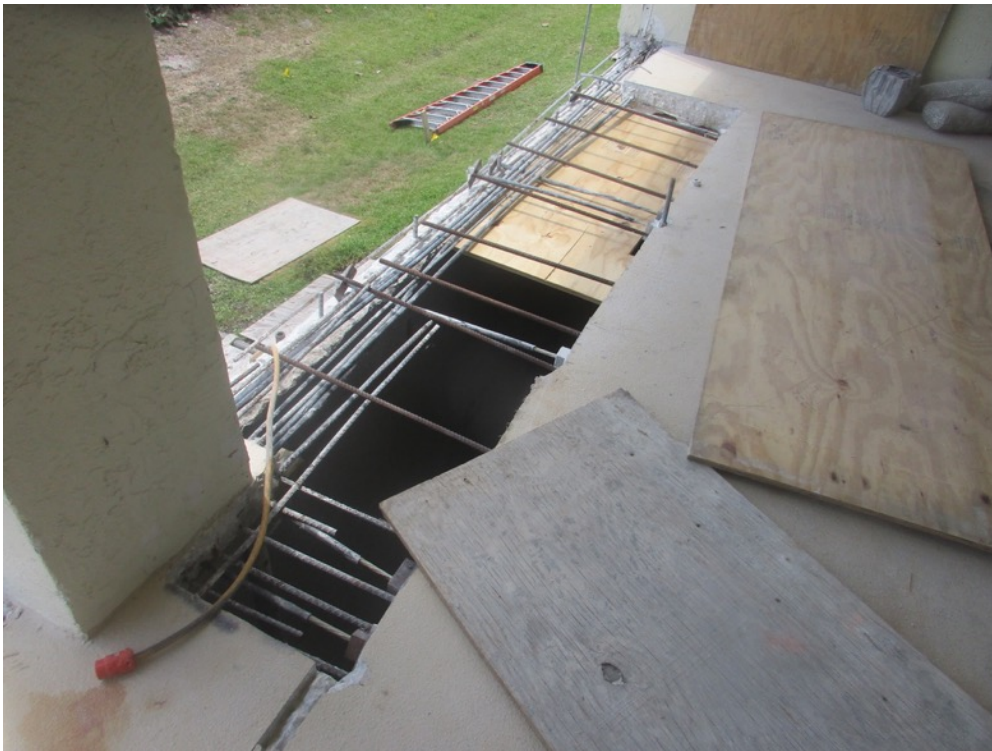
View of slab edge and full depth excavations completed with reinforcing steel install in-progress on the Unit 312 balcony south end

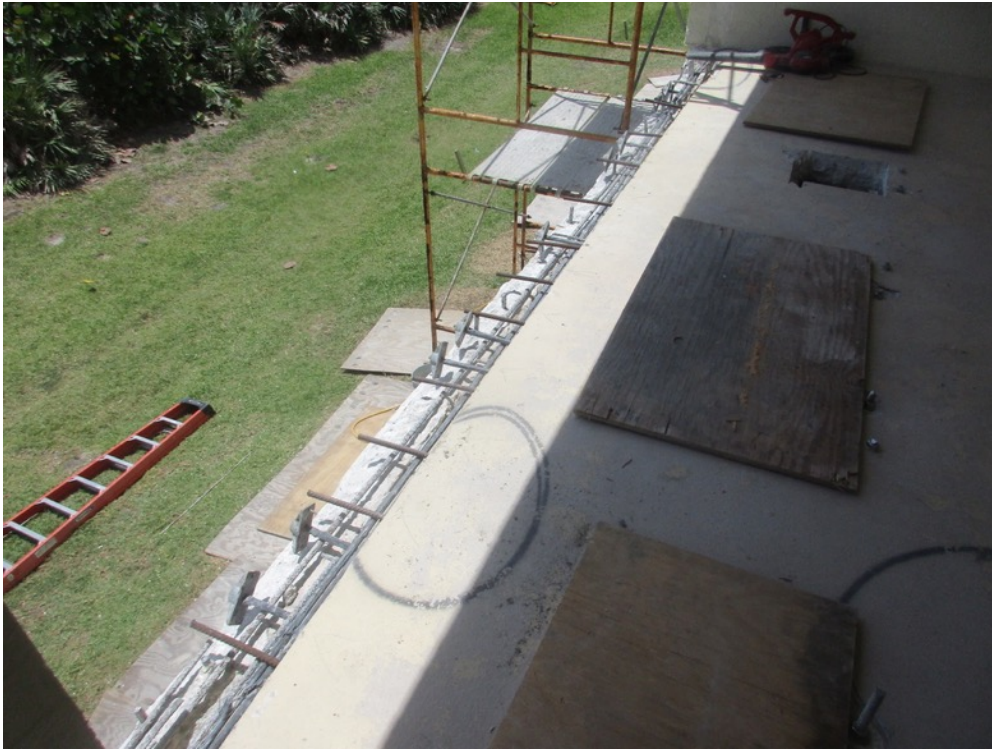
View of slab edge excavations completed on the Unit 313 balcony south end and reinforcing steel install in progress

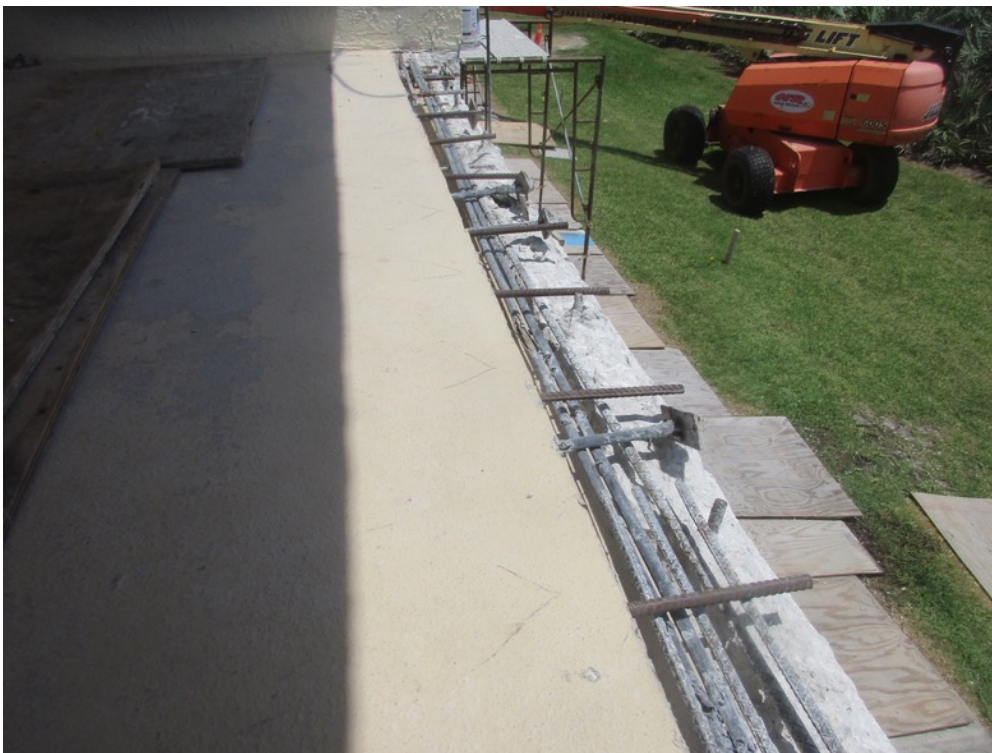
View of slab edge excavations completed on the Unit 313 balcony north end and reinforcing steel install in progress

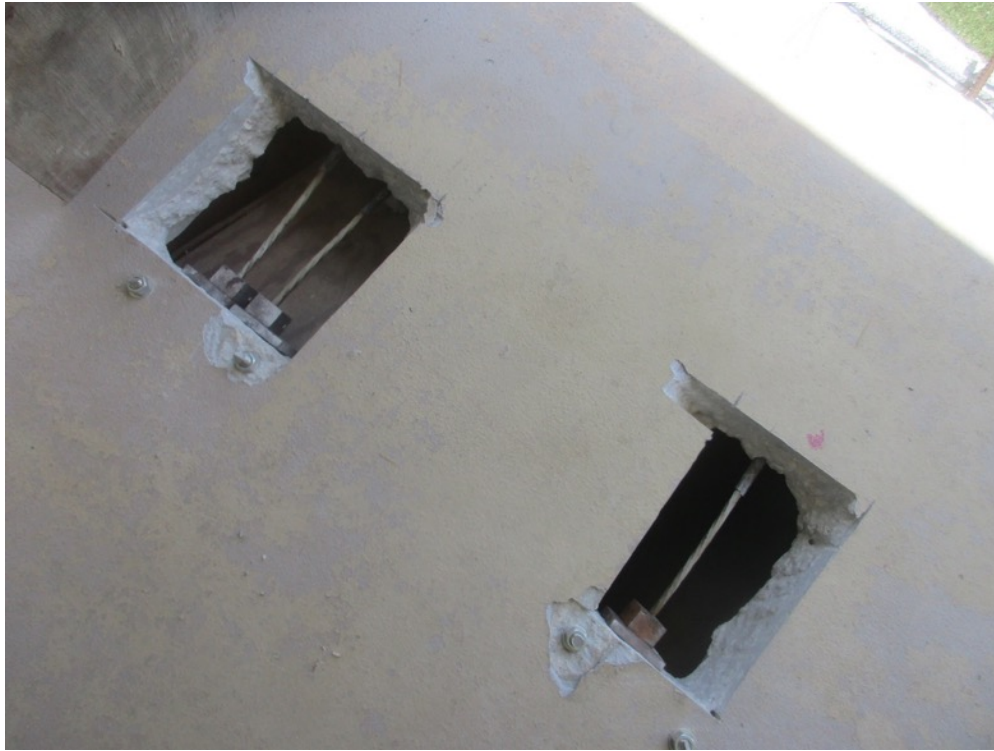
View of east-west PT cables locked-off on the Unit 313 balcony

On the building 3 balconies, east-west post tension cable lock-off installations were completed on Units 313 and 314 in preparation for slab edge excavations. Form construction was wrapped up on the Unit 311 balcony slab edge and post tension cable splice chuck and anchor head installations are scheduled to begin next week.

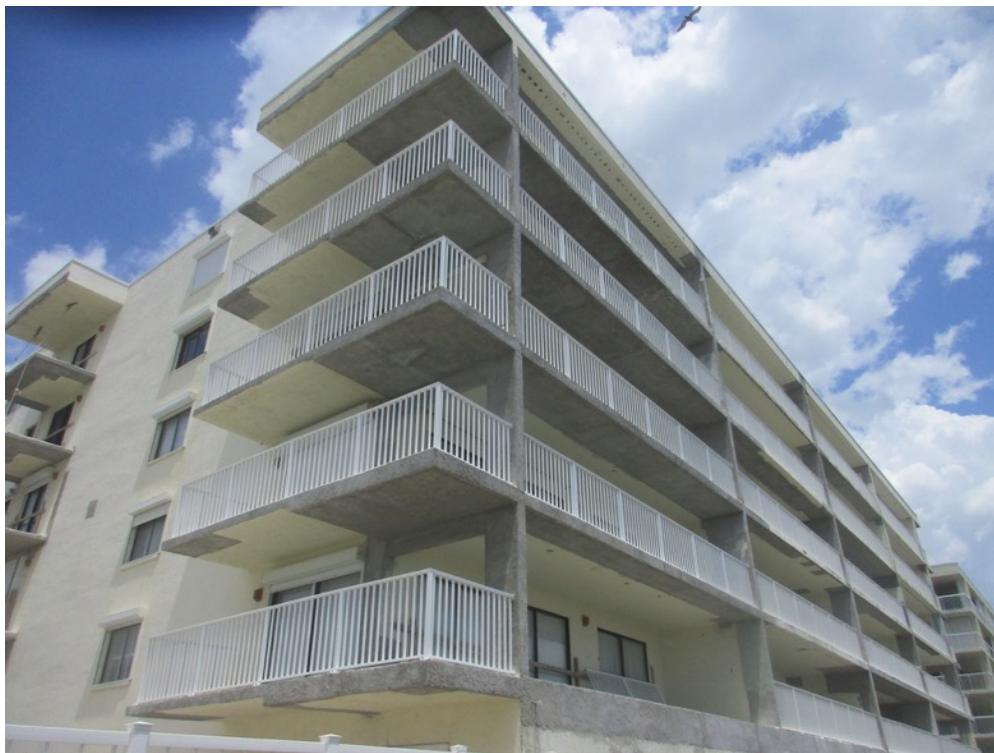
View of handrail installations wrapping up on the building 2 northeast corner 04 stack balconies

On building 2, tile pattern knockdown texture application was finished on remaining 04 stack southwest kitchen balconies. Polyurethane cant beads were tooled at deck-to-wall junctures and waterproofer deck coatings have been applied, scheduled to continue on the walkway decks next week. Handrail installations are wrapping up on the 04 stack southeast corner balconies and windowsill repairs are scheduled to begin next week on the south elevation shearwall.
